California Integrated Waste  
Management Board

February 2009

Contractor's Report  
To The Board

## Detecting Waste Tire Piles Using High-Resolution Remotely Sensed Imagery

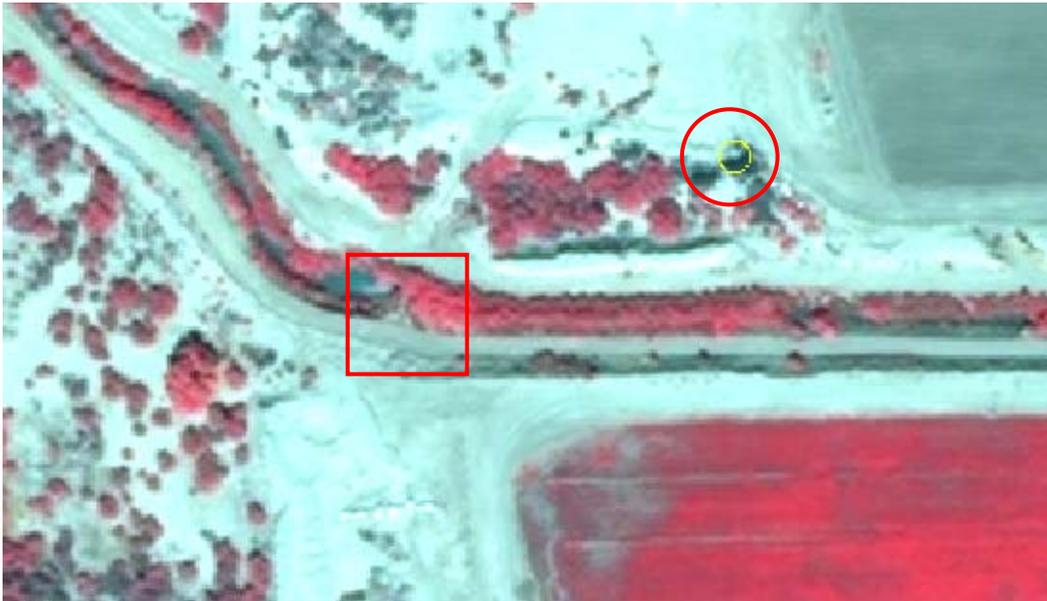
been within 300 feet from the target and have photographed an object other than the target. The pictures below illustrate how location errors can impede inspection. In the satellite image (Figure 1), vegetation appears red. The inspector's picture (Figure 2) may have been taken from the location indicated by the square. The target area, indicated by the circle, is less than 100 yards away, behind some brush. We feel that the snapshots will reduce the likelihood of such mistakes.

**Figure 5. QuickBird image showing target area (circle) and possible location of misidentified area (square) (DigitalGlobe, 2006).**

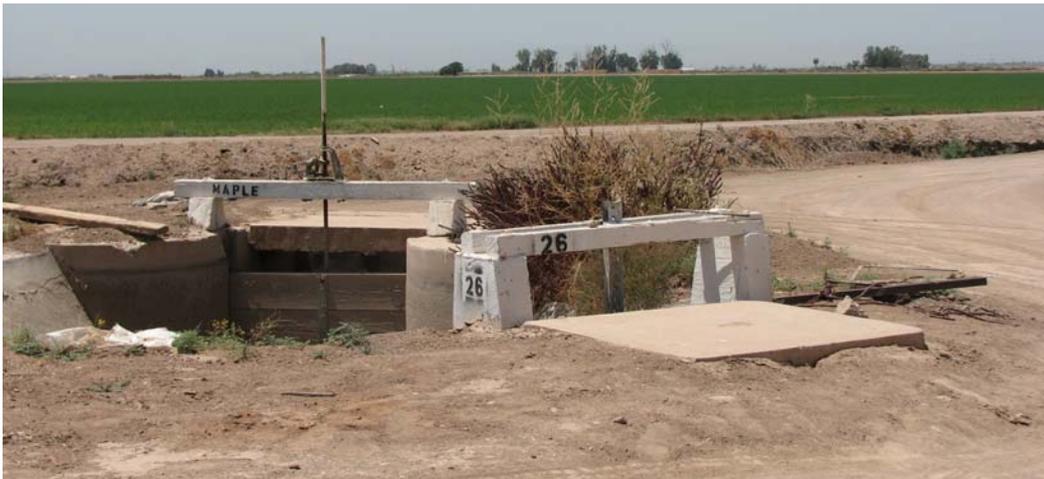
**Figure 6. Photograph of misidentified location (Silva, 2007).**

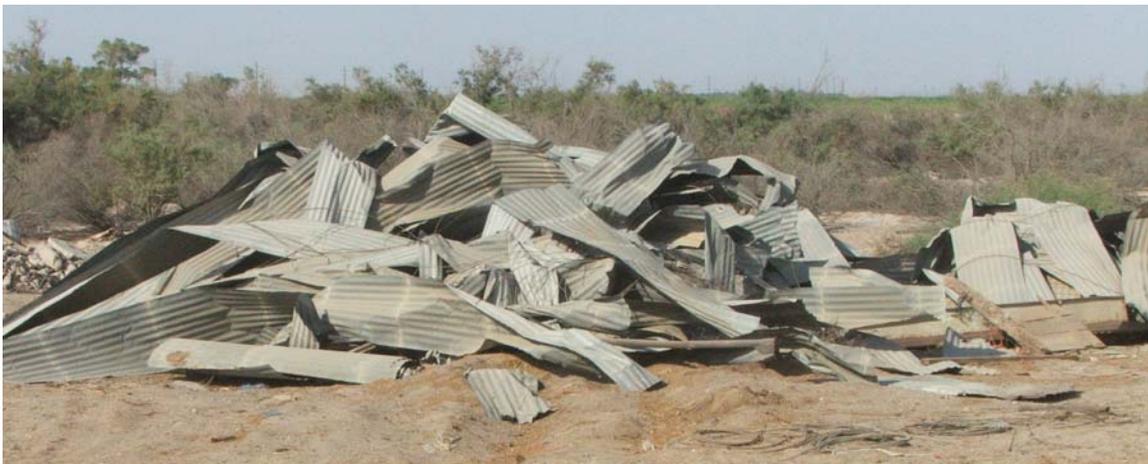
**Figure D-2. Metal debris at site 4 (Silva, 2007).**

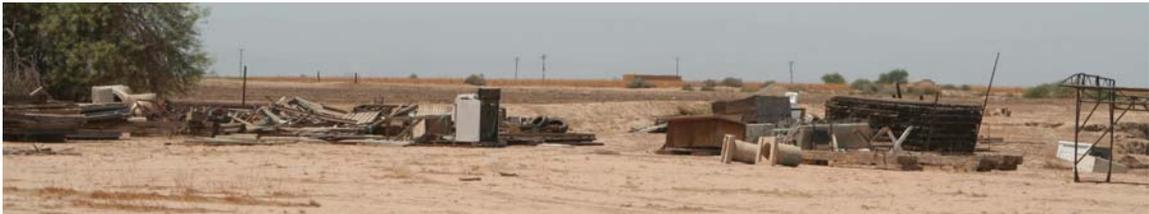
**Figure D-4. Debris at site 46 (Siefert, 2007).**

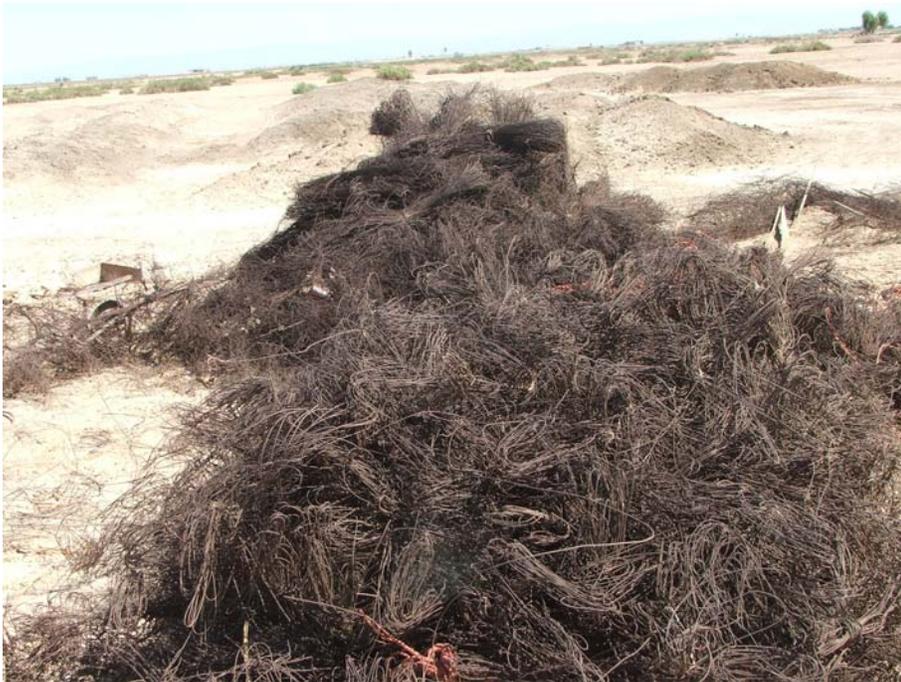
**Figure D-6. Black wires at site 123 (Silva, 2007).**
