LANDFILL GAS MONITORING & CONTROL STRATEGIES at DEVELOPED SITES

Sponsored by the:
CALIFORNIA INTEGRATED WASTE MANAGEMENT BOARD

Developed and Presented by:
SCS Engineers & GC Environmental, Inc.

Belmont Shores Landfill

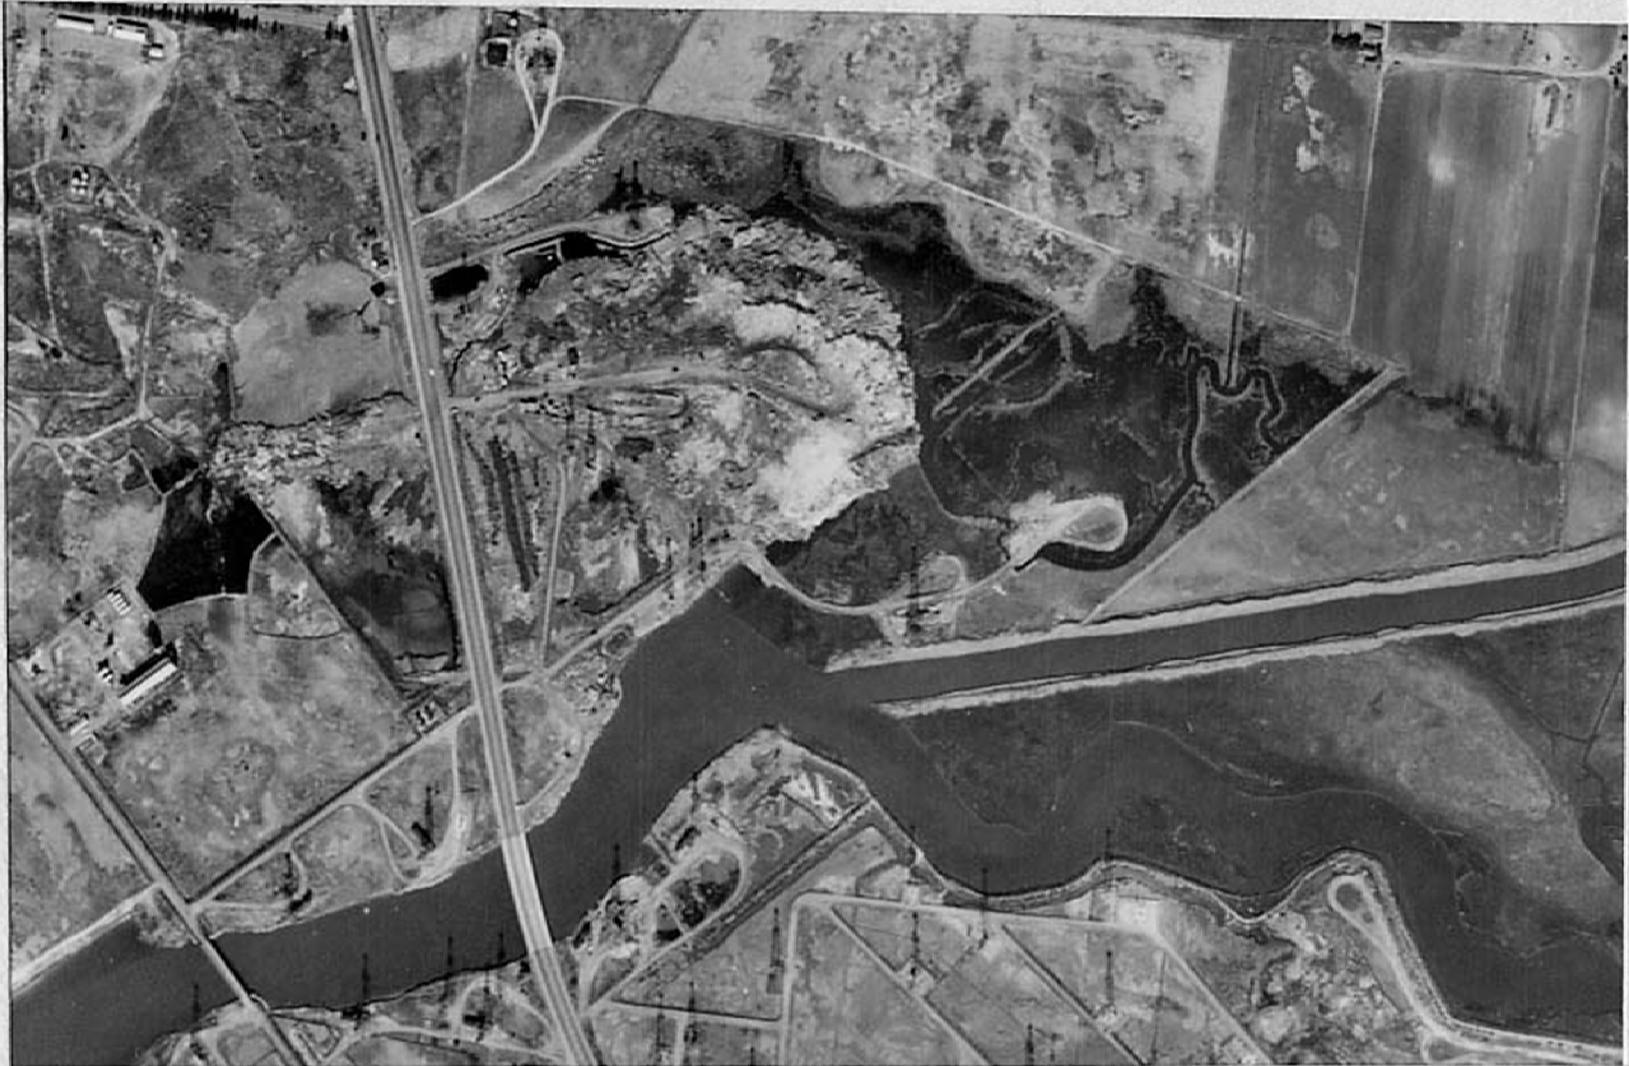
Approximate Locations of Belmont Shores
The Gaslamp, The Golden Sails Best Western
The PCH Club and The Bahia Marina

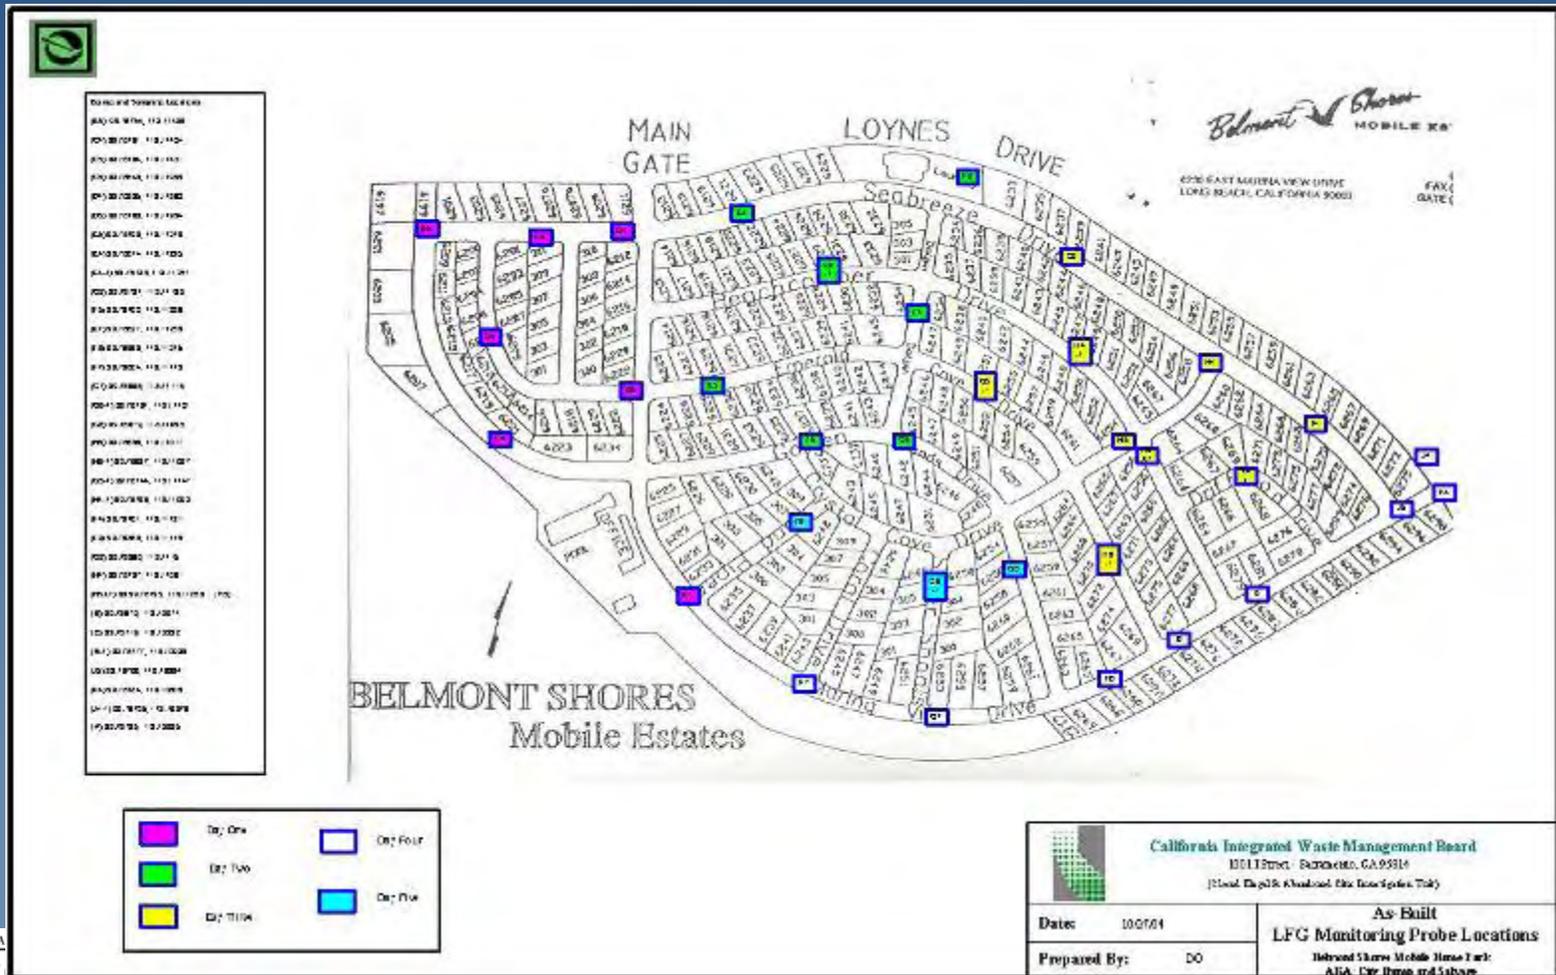
Investigation 33 Probe Locations

- Geophysical
- Installation of 37 multi-level gas monitoring probes
- 33 in Belmont Shores
- 4 around the perimeter
- Gas samples taken and sent to Lab
- Bi-weekly monitoring conducted by LEA and CIWMB

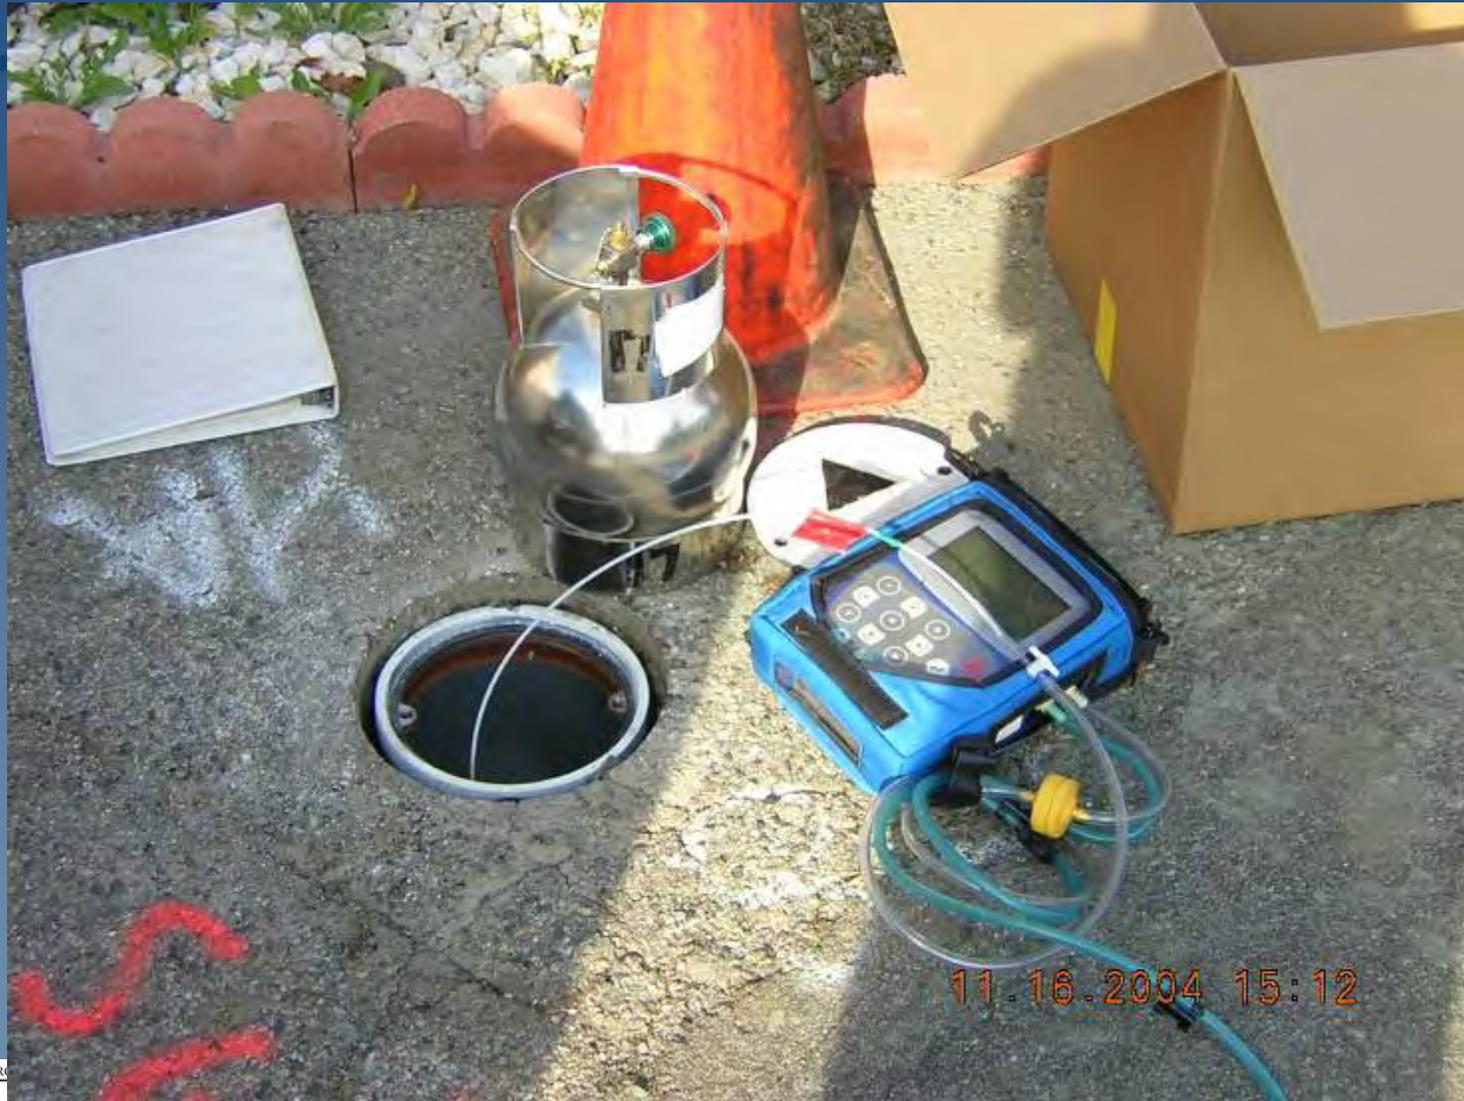
Gas Sampling

11.16.2004 15:12

Average Gas Concentration 51.20% Under The Cap

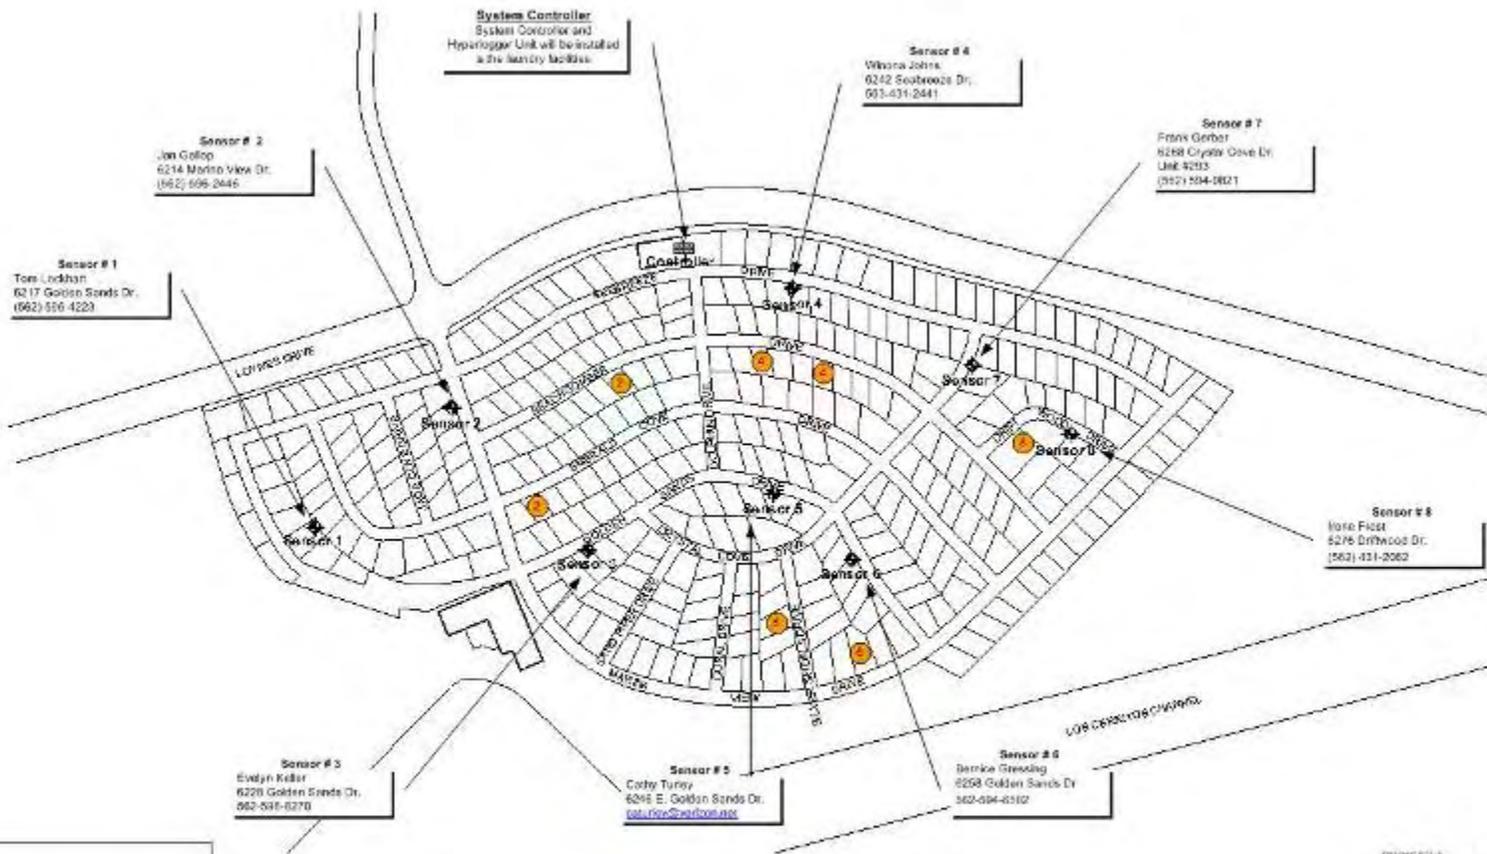
Sensor Locations

- Need to determine if surface migration exists
- Logic for sensor locations chosen (zones)
- Placement of 24/7 methane sensors
- 8 locations

1. At each sensor location, a radio transmitter (RSP7002T) will also be installed to pair with a sensor.
2. Optional locations are to be used in case a first choice location is not suitable for sensor installation due to unforeseen circumstances.

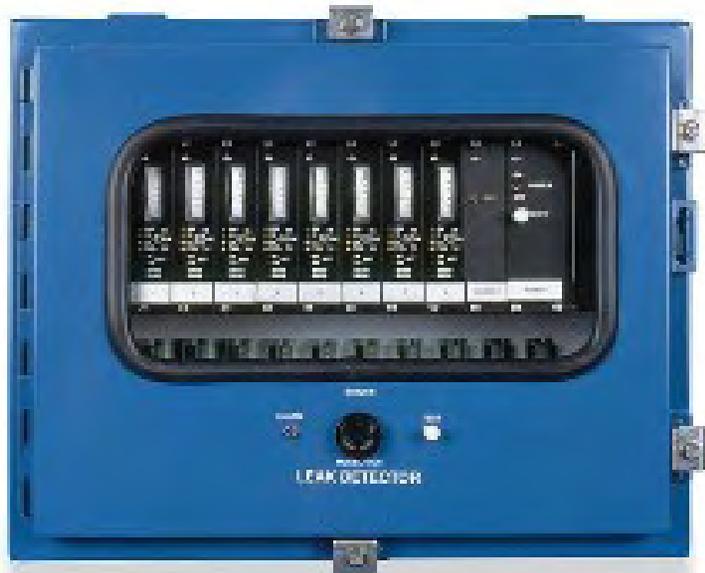
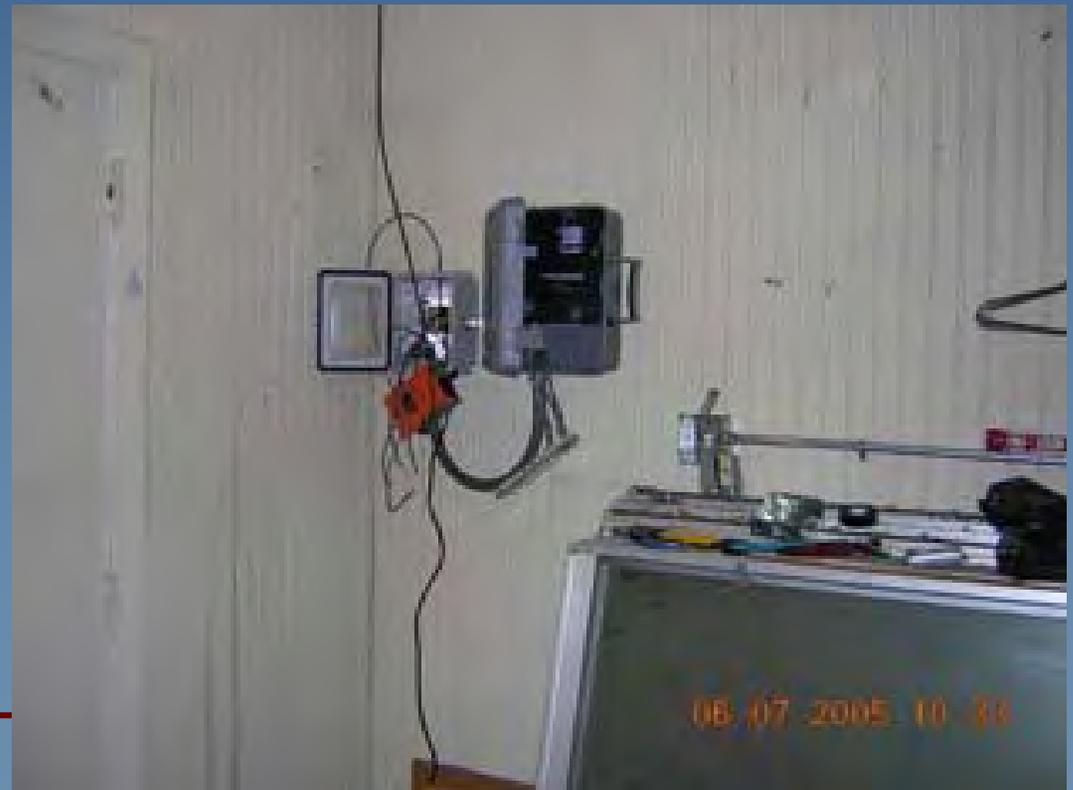
Controller and Data Logger System is Currently Operating

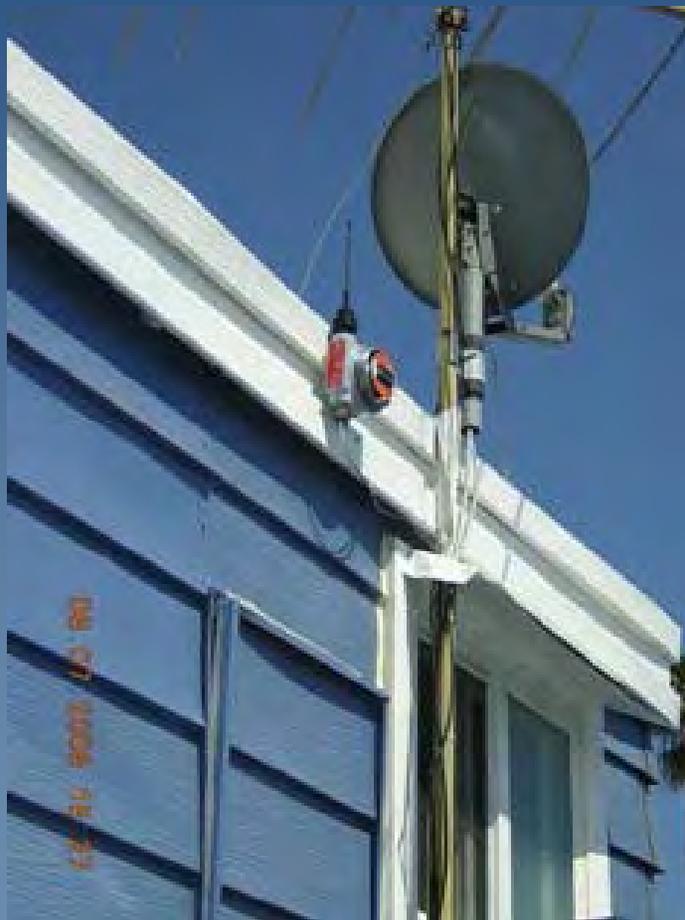
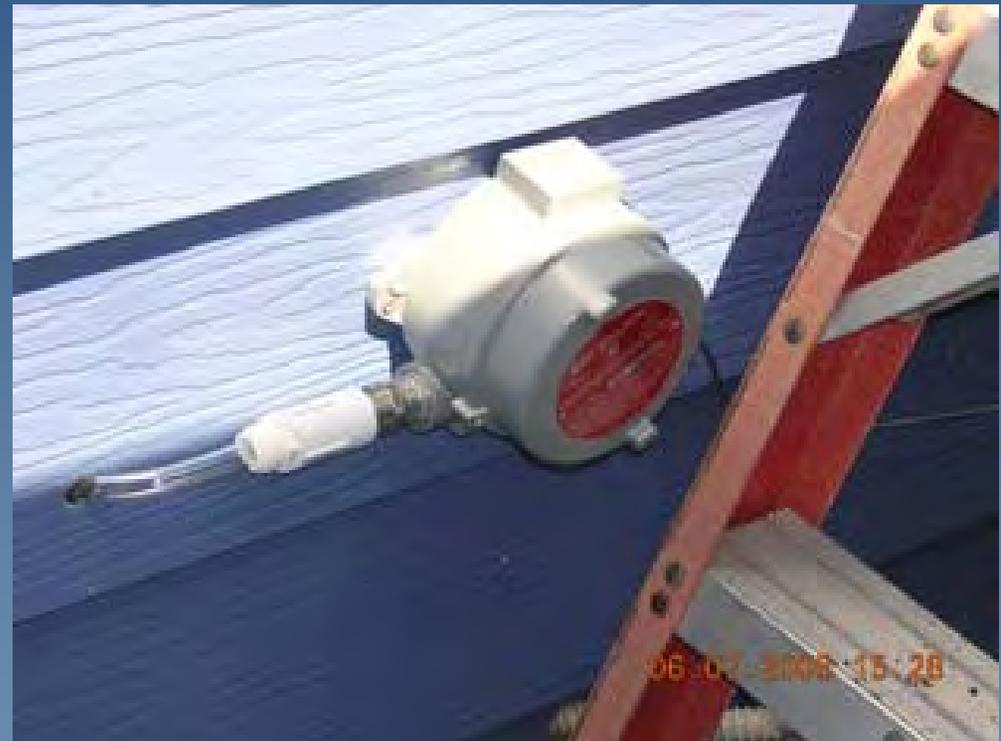
Sensor Unit and Transmitter

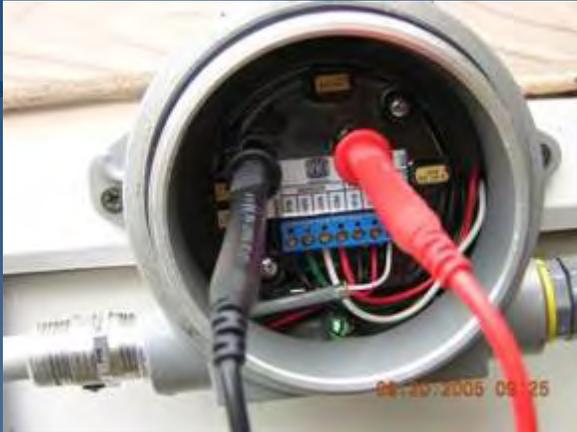
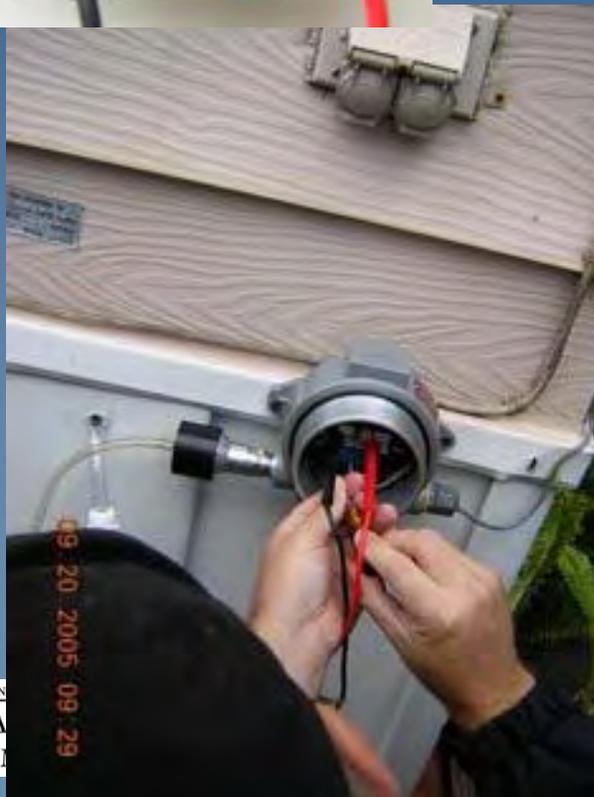
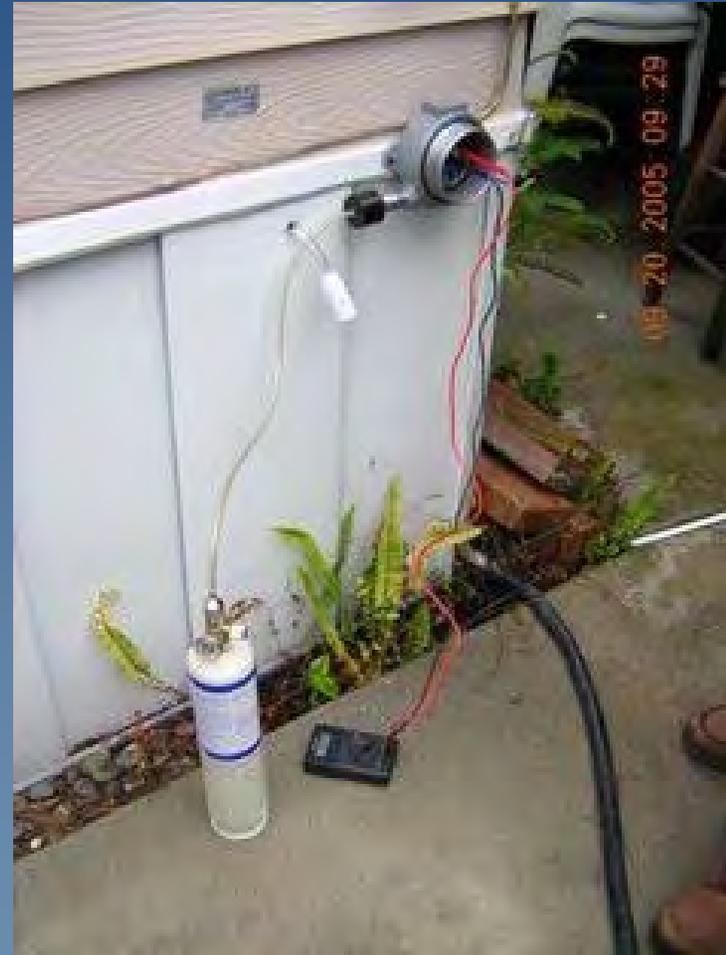
Calibration

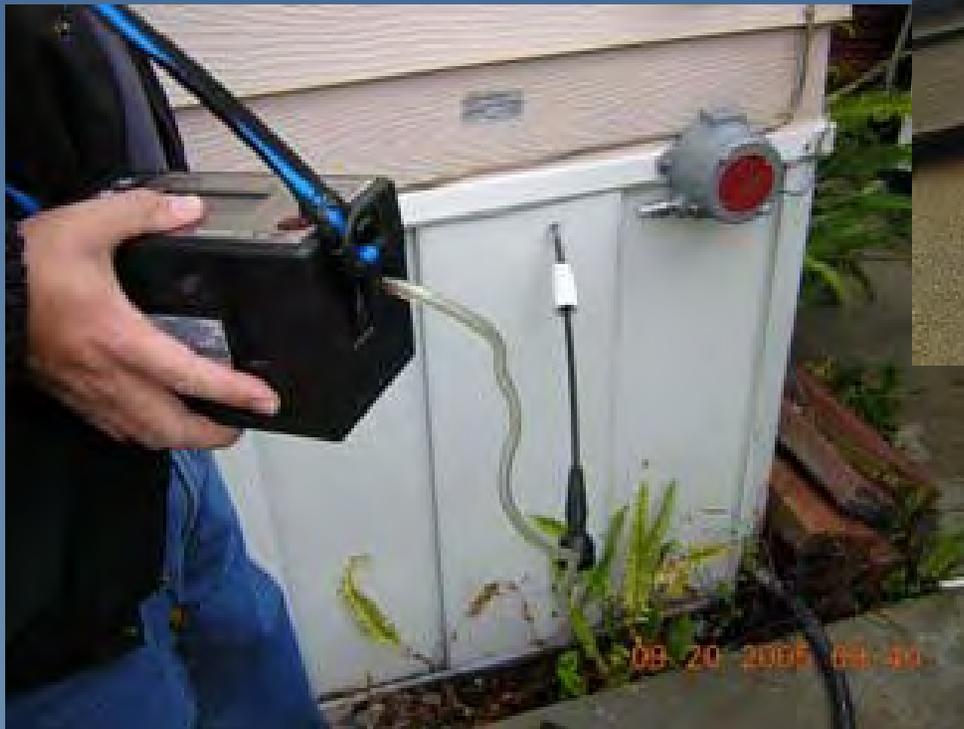
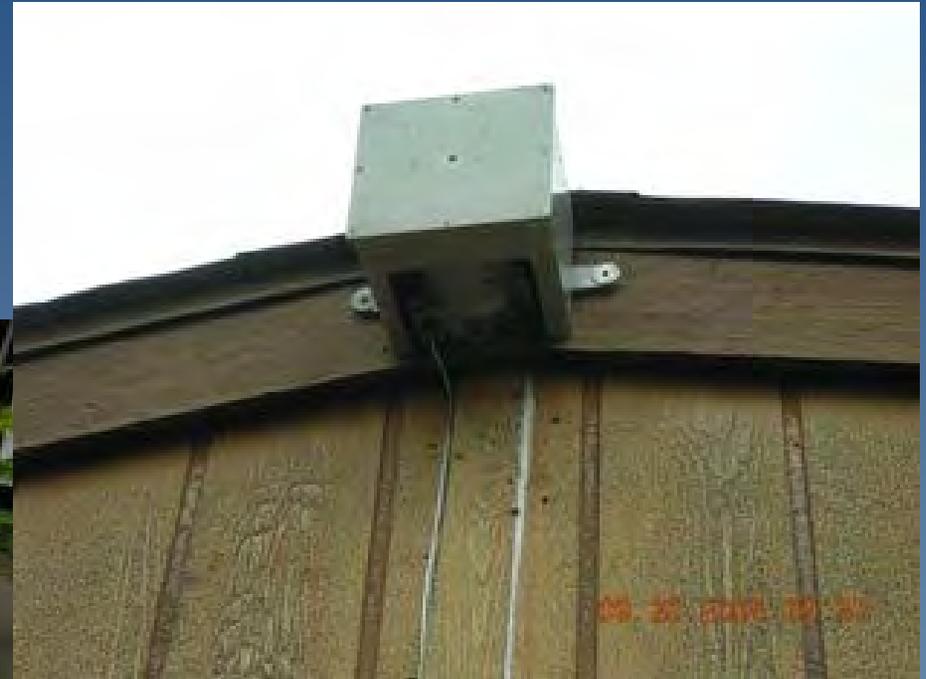
Sensor Operation and Housing

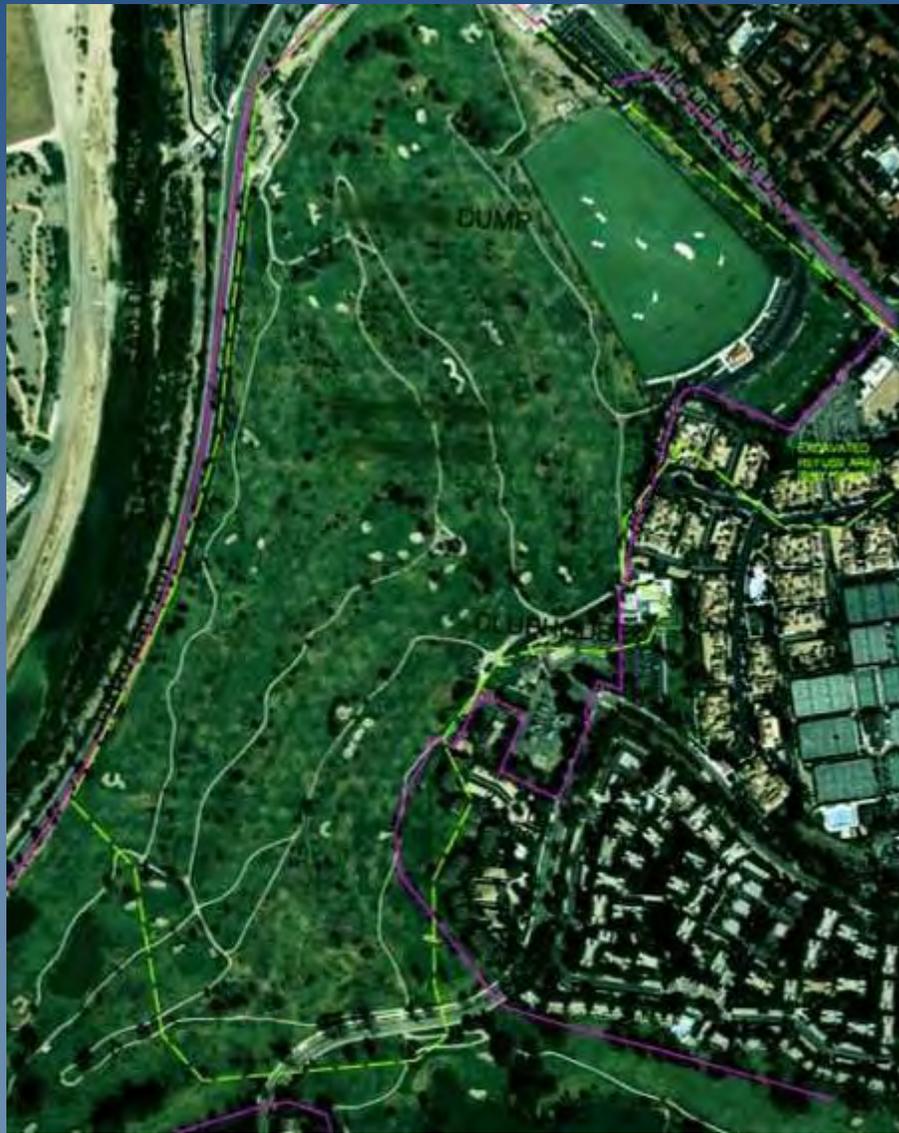
Landfill #1 - Setting

- 115-acre cut and cover operation
- Operated over 5 years (1960-1964)
- Property and surrounding area undeveloped at time of closure
- Golf course development on-site since 1965

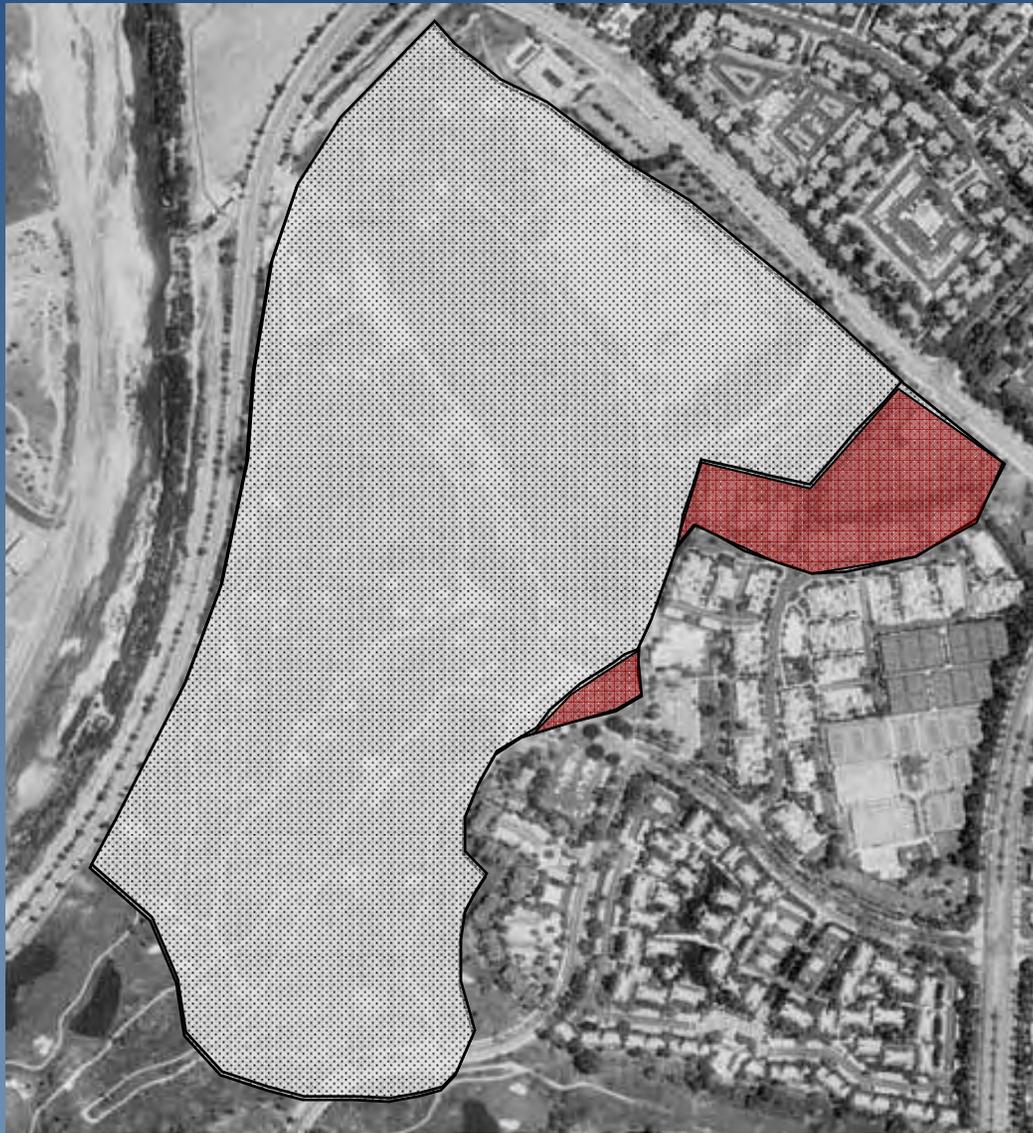
Landfill #1 – Setting Refuse Extent

- Original landfill Extent (at time of closure)
 - A portion of refuse excavated for residential and commercial development
 - Current refuse Extent
-

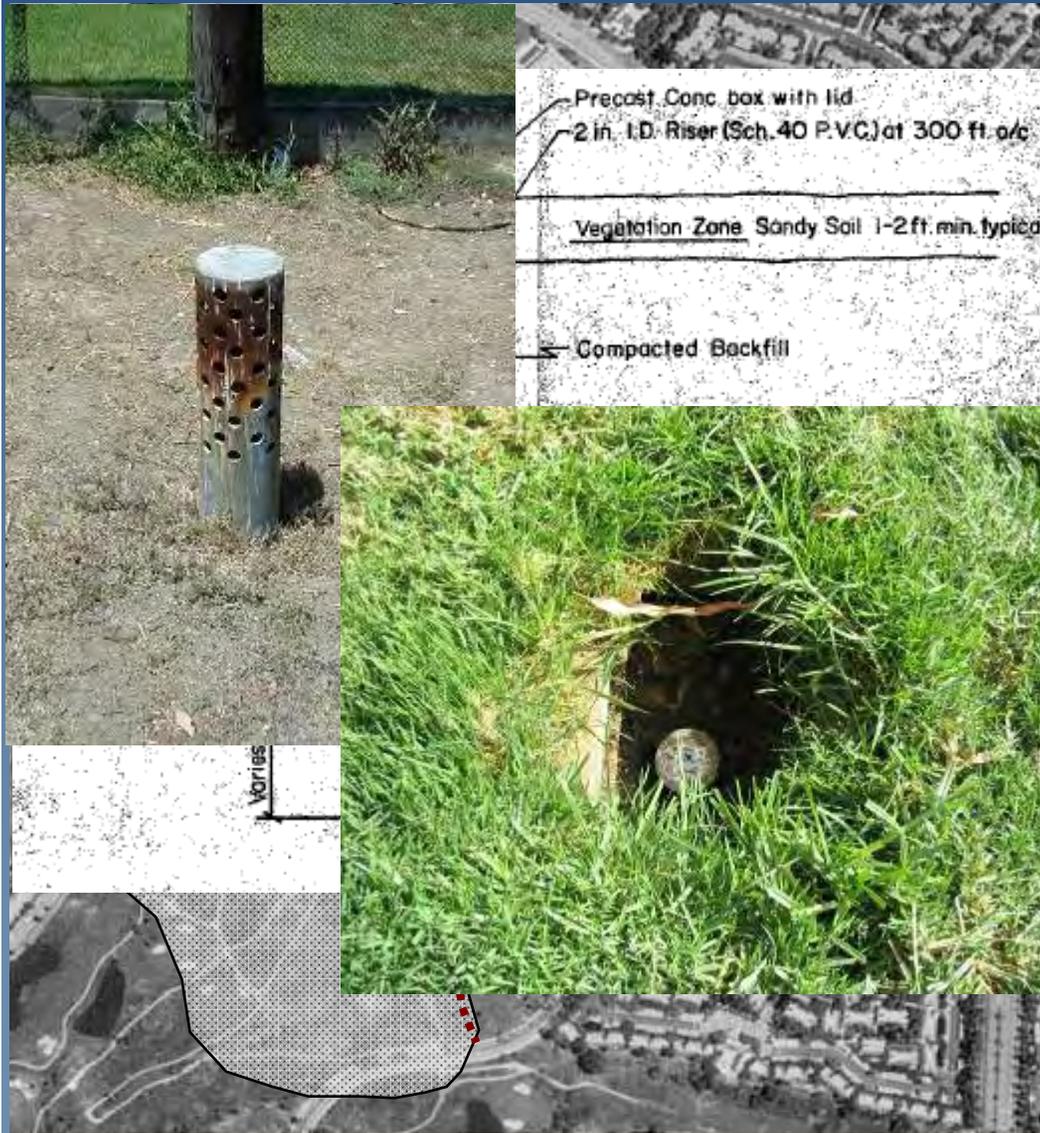
Landfill #1 – Setting Historic Perimeter Gas Barrier

- Perimeter Gas Barrier/Passive Vent Trench installed prior to adjacent developments
- Perimeter Gas Barrier/Vent Trench Detail
- Limited, non-contiguous remnants of vent system identified on-site

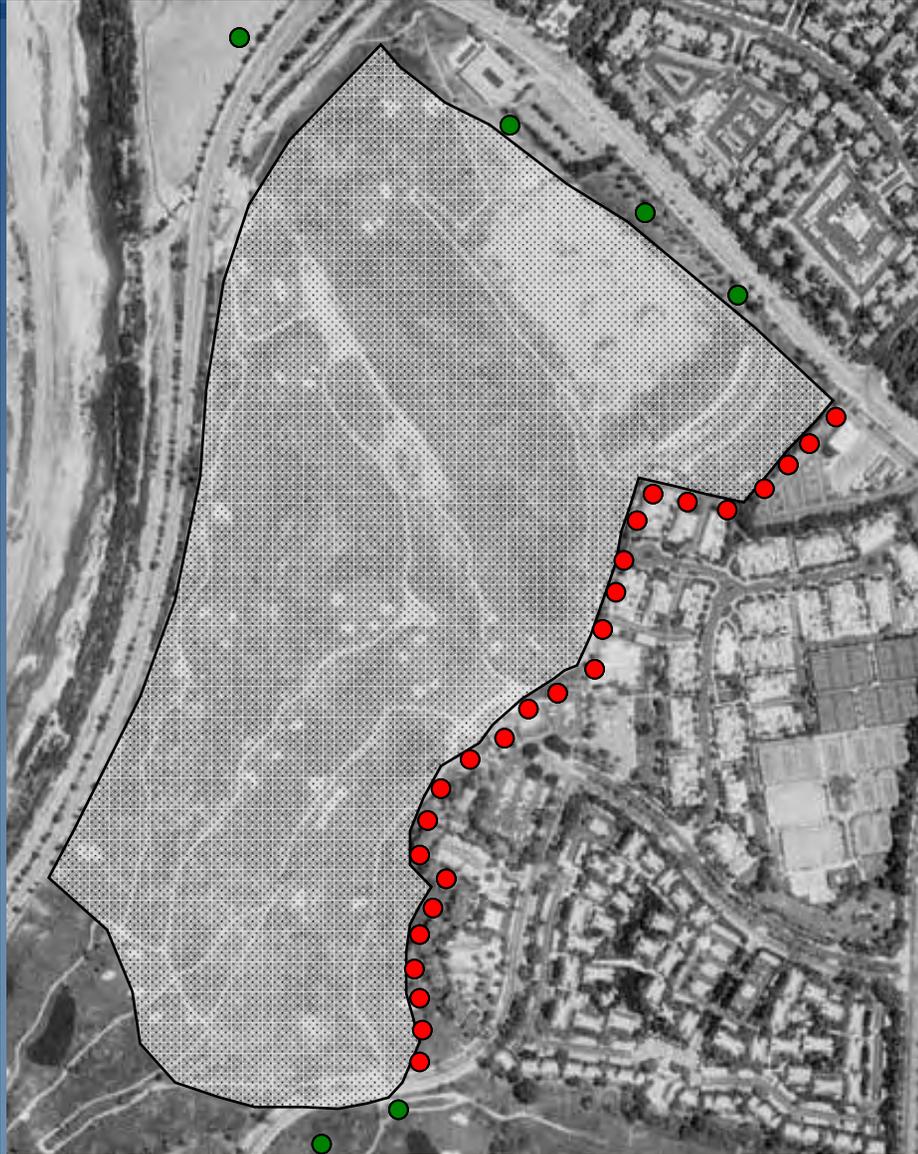
Landfill #1 – Setting Perimeter Probe Installation

- Original network of 11 perimeter probes installed at site in 2002
- Based on exceedances, 24 additional probes installed
- 29 out of the 35 probes (eastern perimeter) have methane levels above 5%

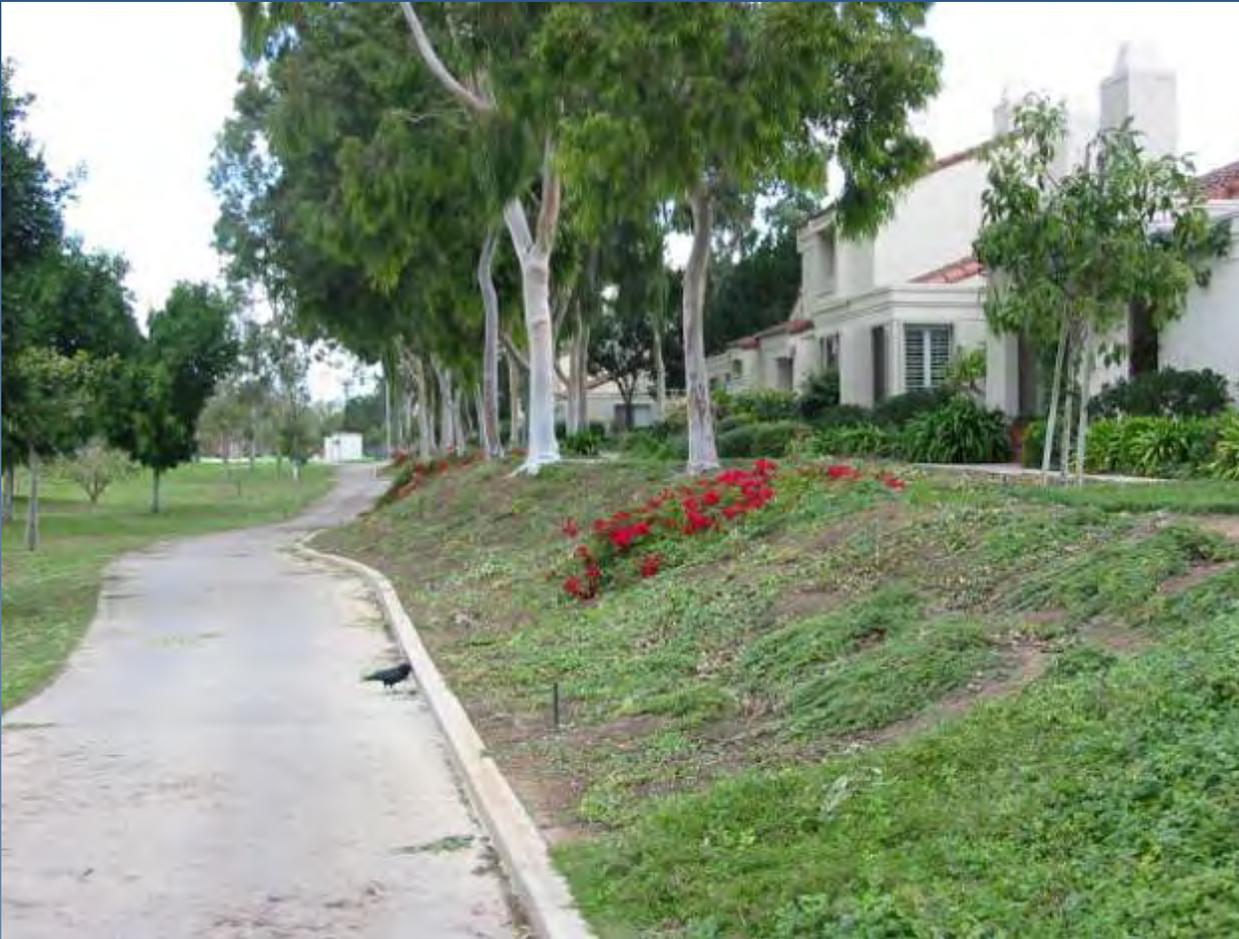
Landfill #1 – Emergency LFG Monitoring

- In-house monitoring of residential structures performed over Thanksgiving Holiday due to elevated probe readings

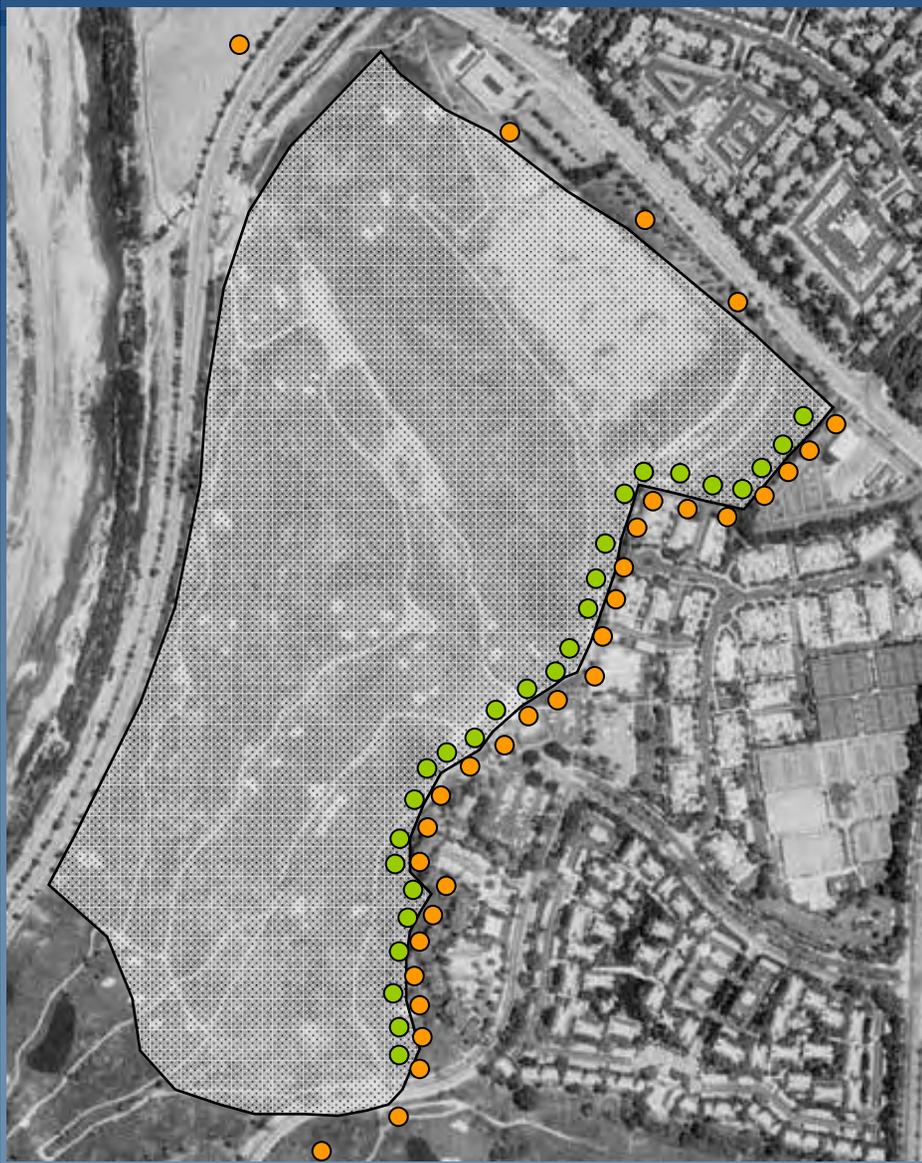
Landfill #1 – Perimeter GCCS

- 28 perimeter extraction wells will be installed at the site
- Wells interspersed with probes at 100-foot spacing
- Wells to be located in refuse and/or soil, based on field conditions

- Proposed perimeter GCCS must integrate with the existing golf course
 - Subgrade header installed adjacent to cart path
 - Installation of system split into separate sections to allow for installation during slow season
 - Former Gas Barrier/Vent Trench integrated with GCCS by running laterals to vent risers

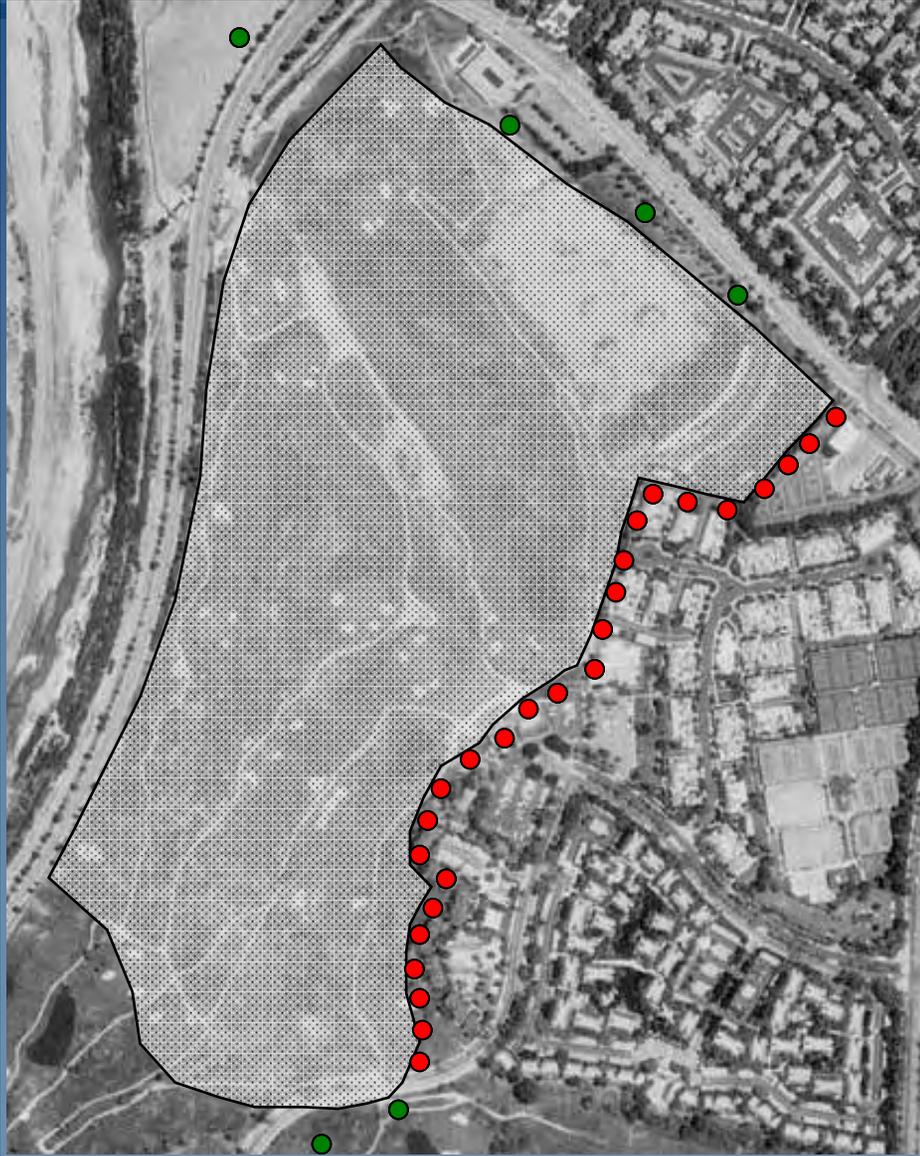
Landfill #1 – Northern Perimeter Probe Issues

- Probe violation (>5%) in February 2006, after 3 years of non-detect
 - Exceedances continued through August '05
 - No exceedances since August '05
- Probe located in adjacent to unlined drainage alignment
- Significant rains during '04-'05 season

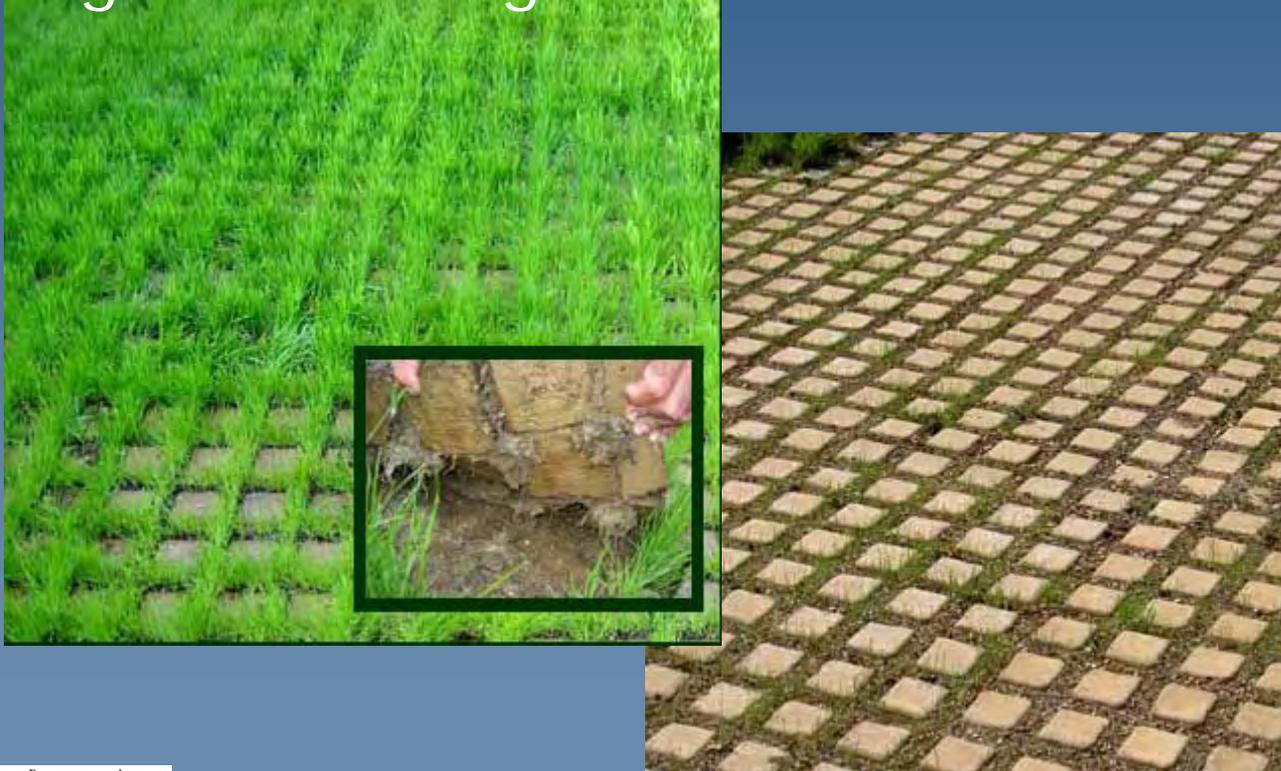
Landfill #1 – Northern Perimeter Probe

- Drainage area repaved to expand parking area
- Proposed parking area paving altered to allow for LFG migration through landfill cover
