**San Mateo Landfill Closure,
Phase II
&
Seal Point Park**

Scope of Work

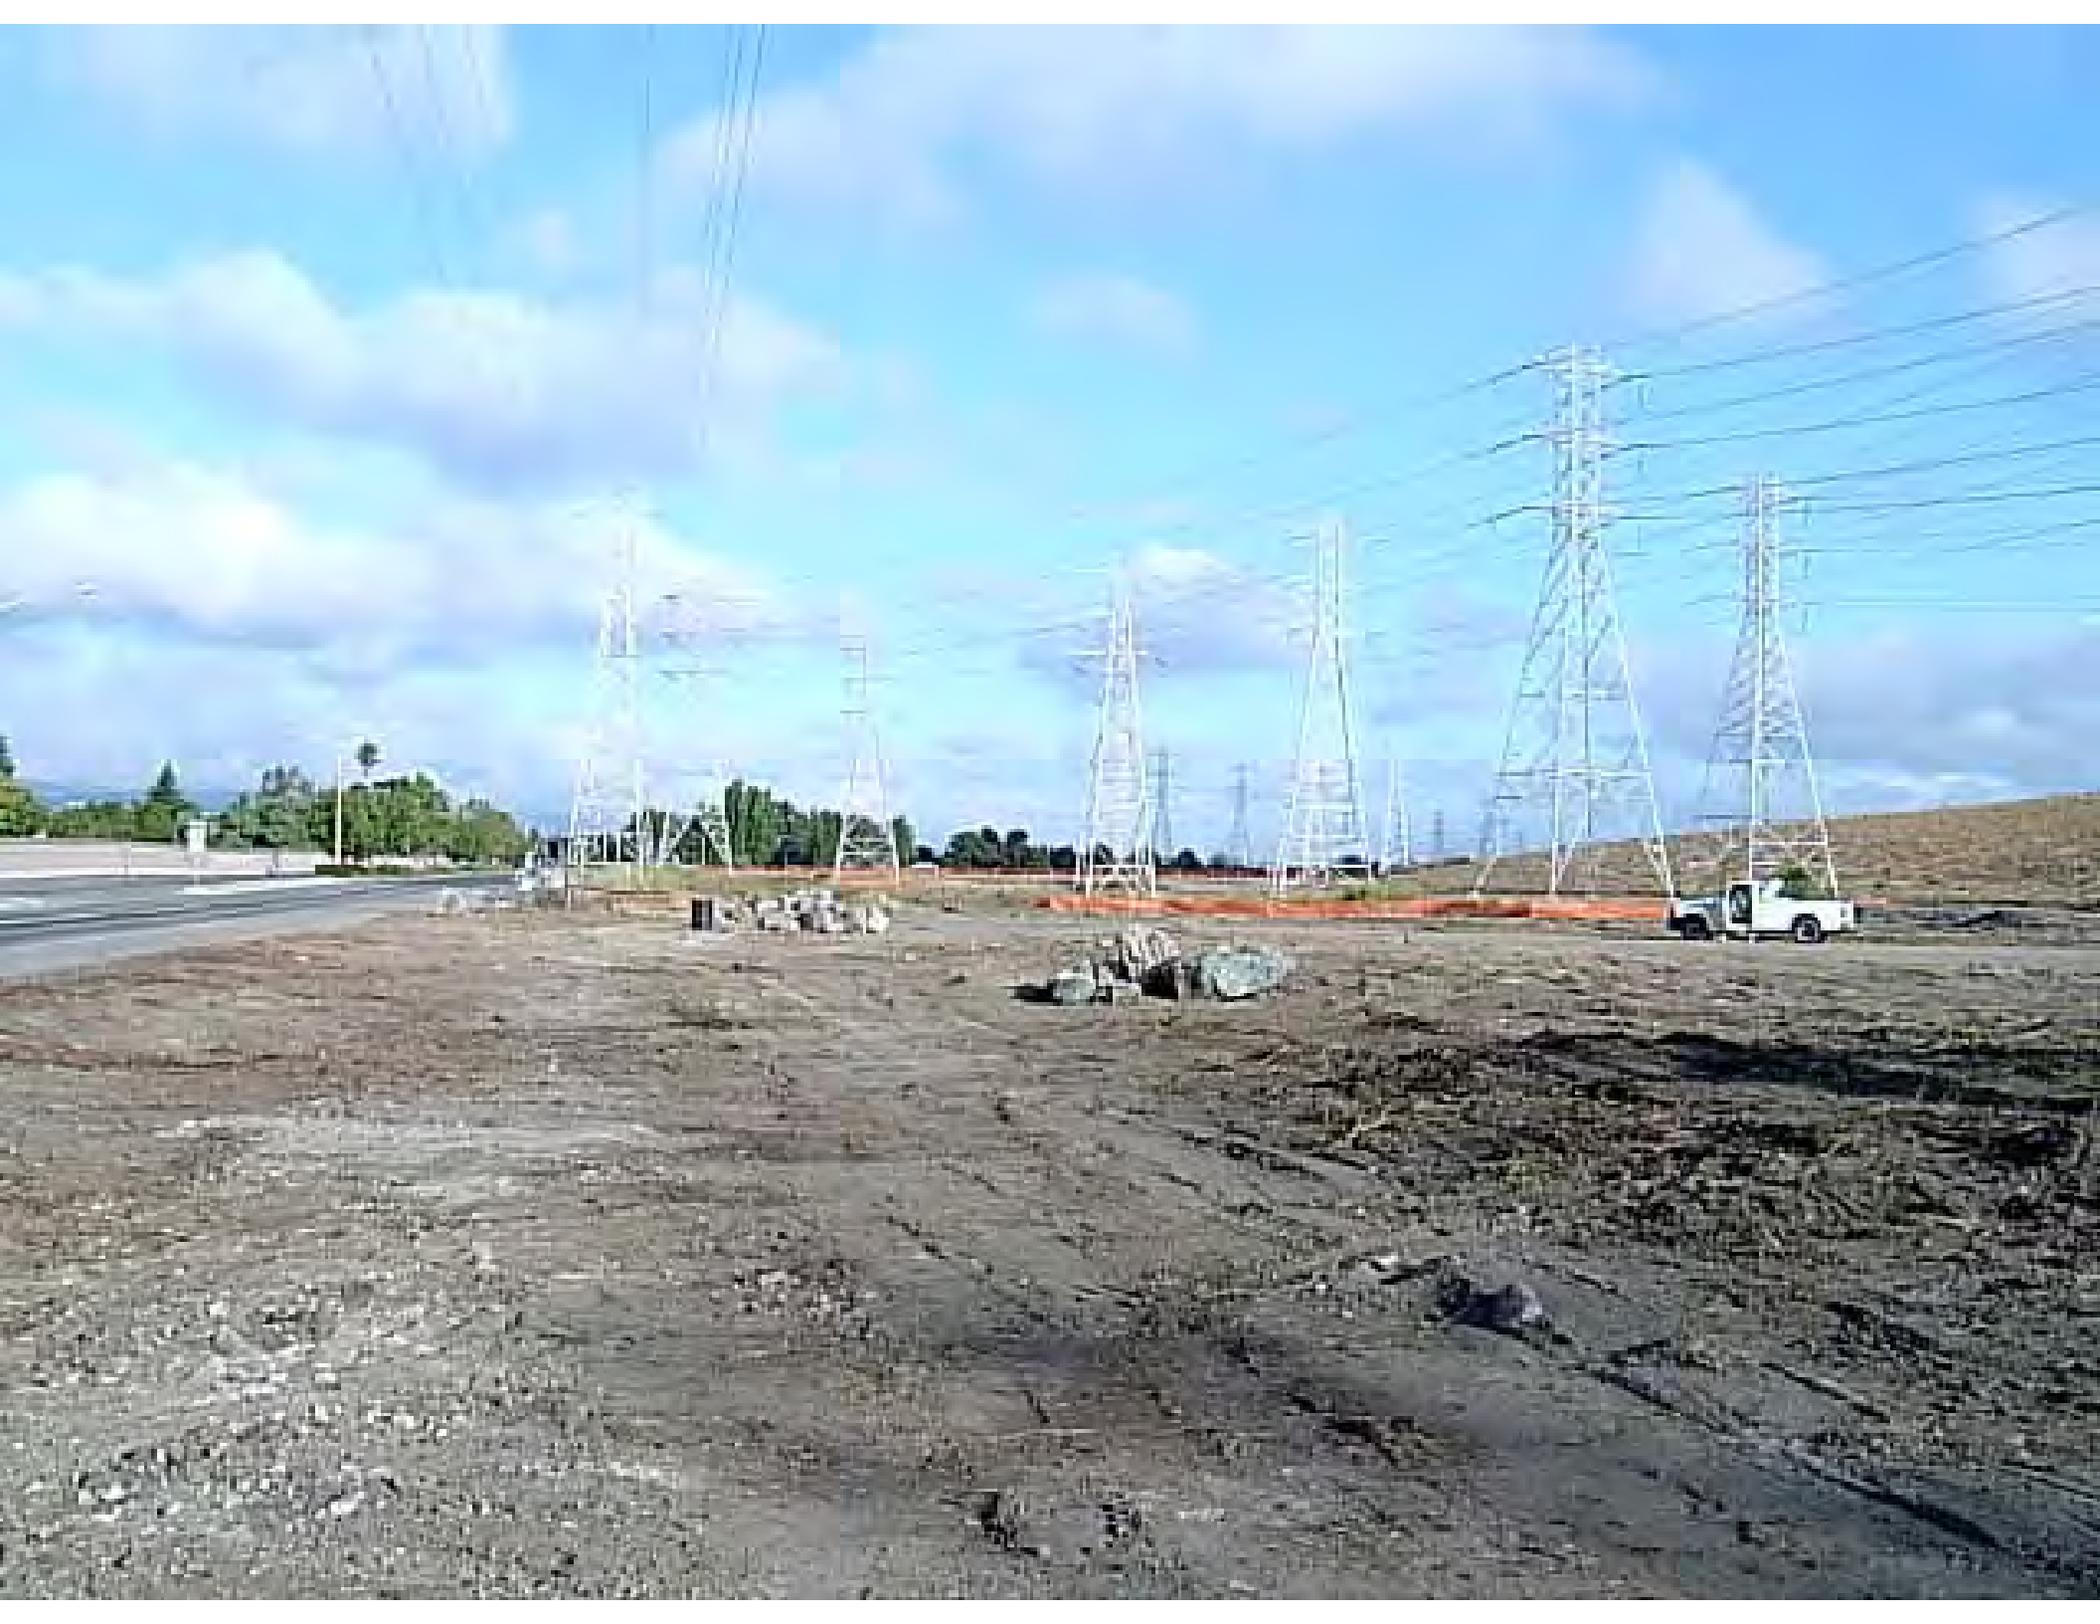
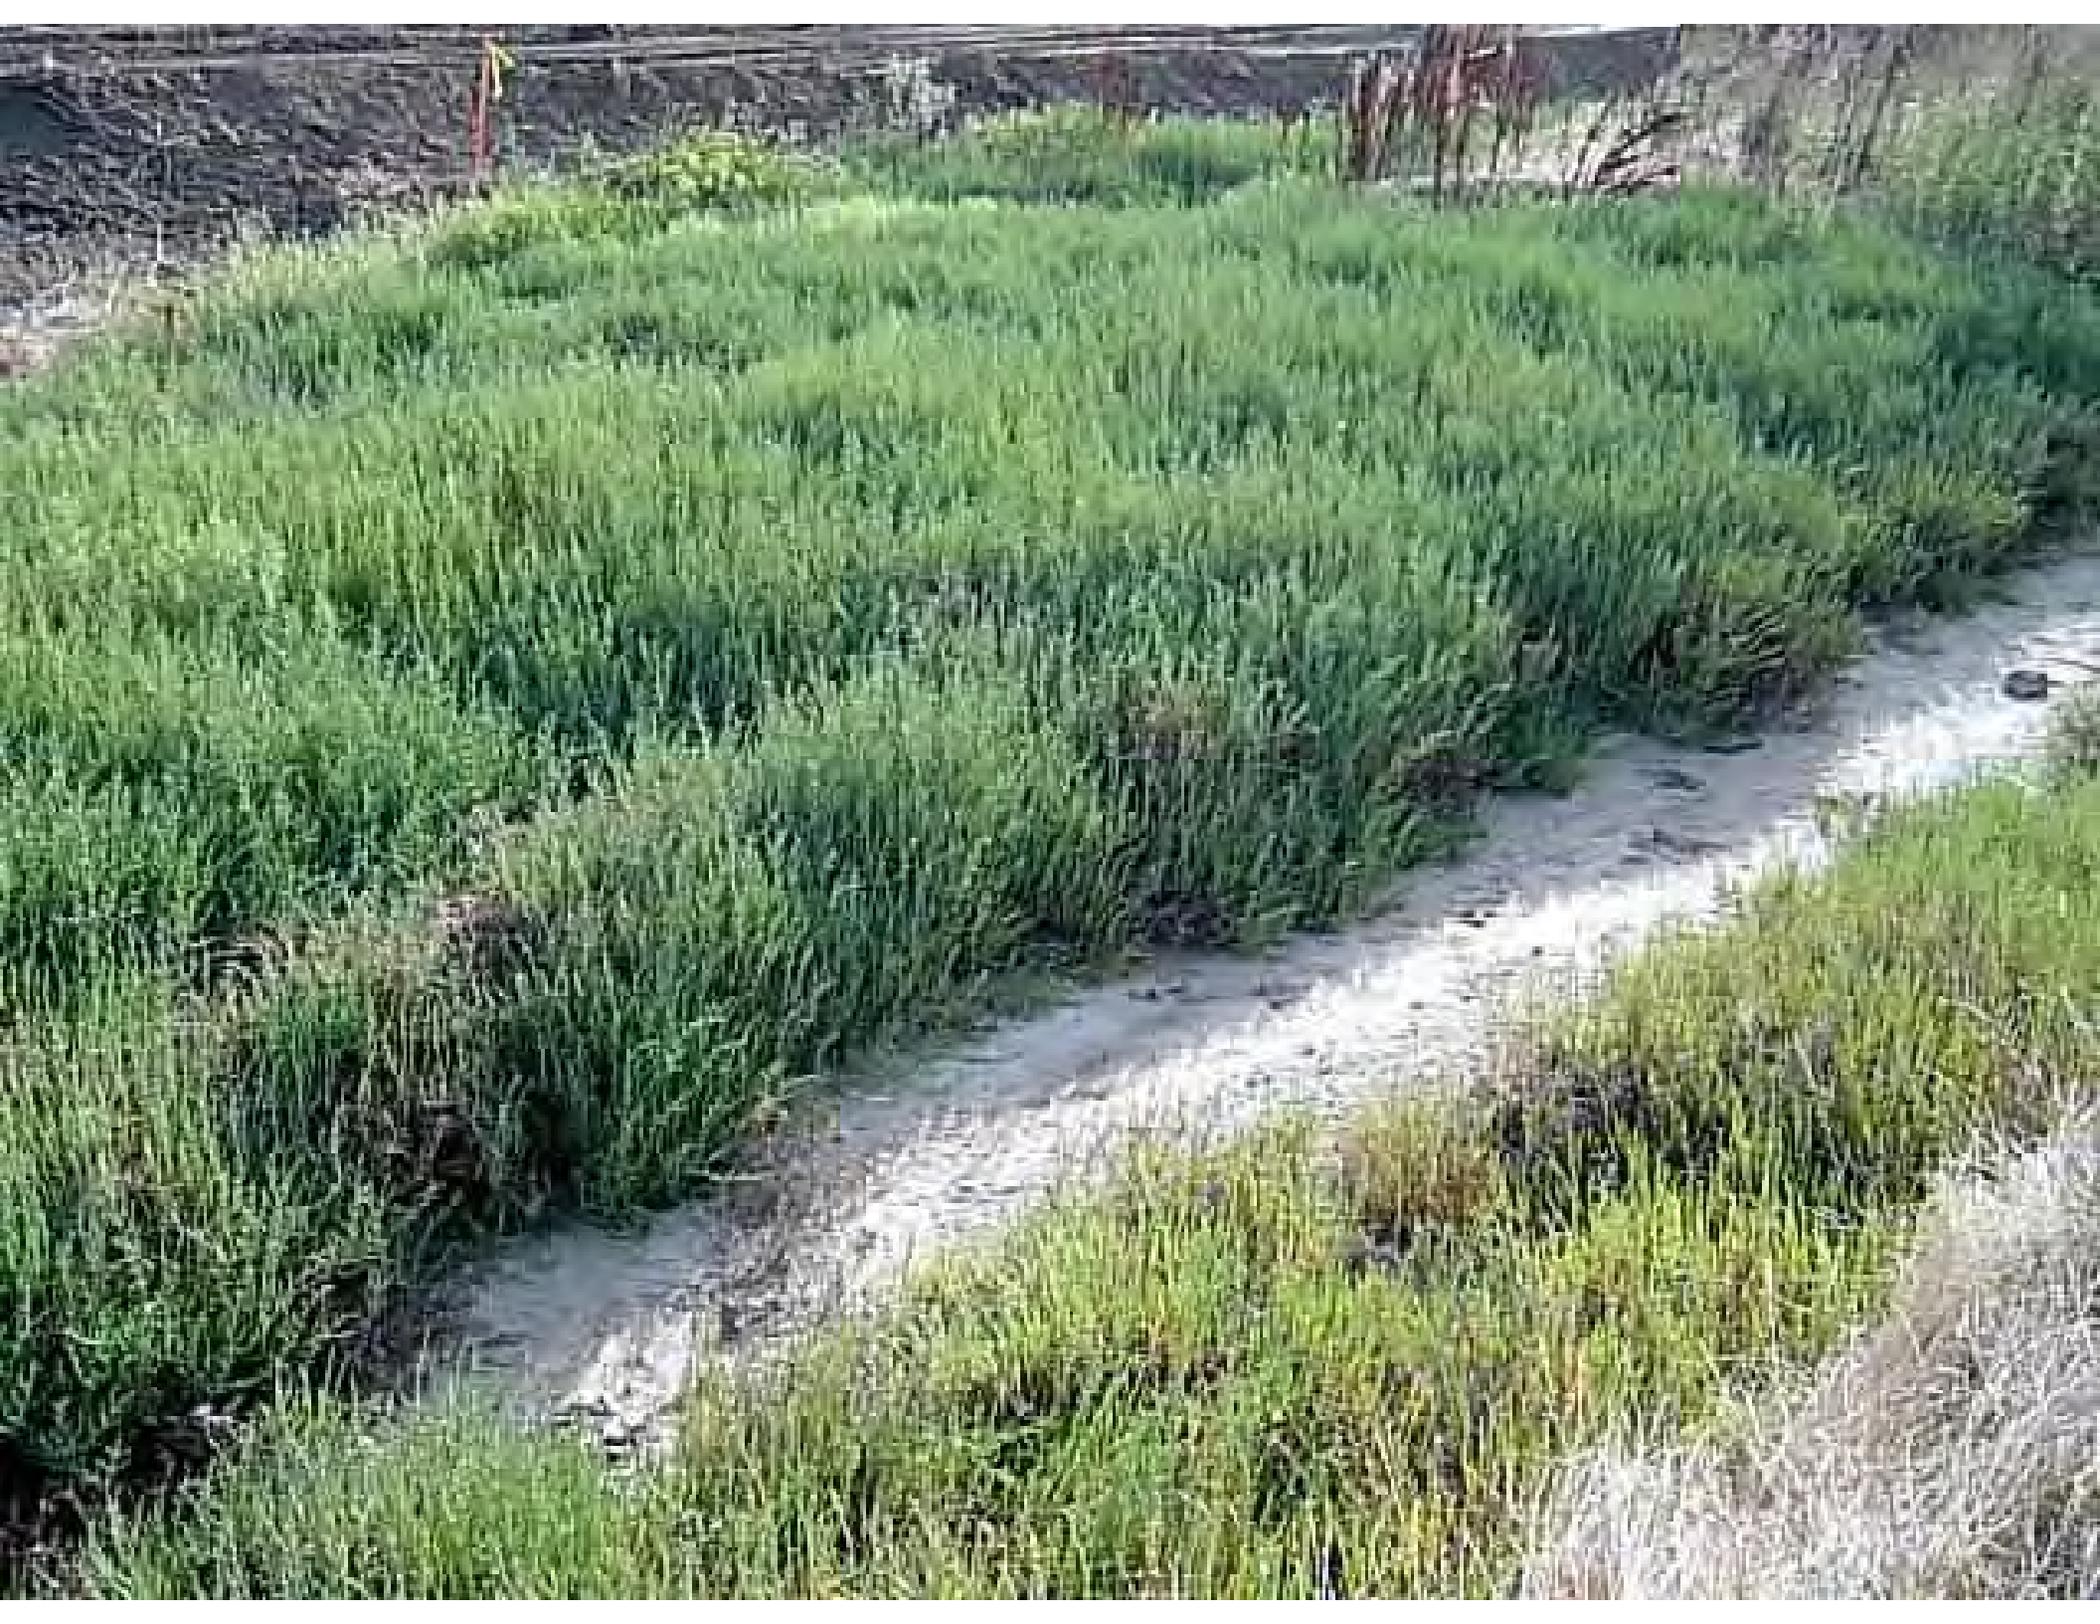
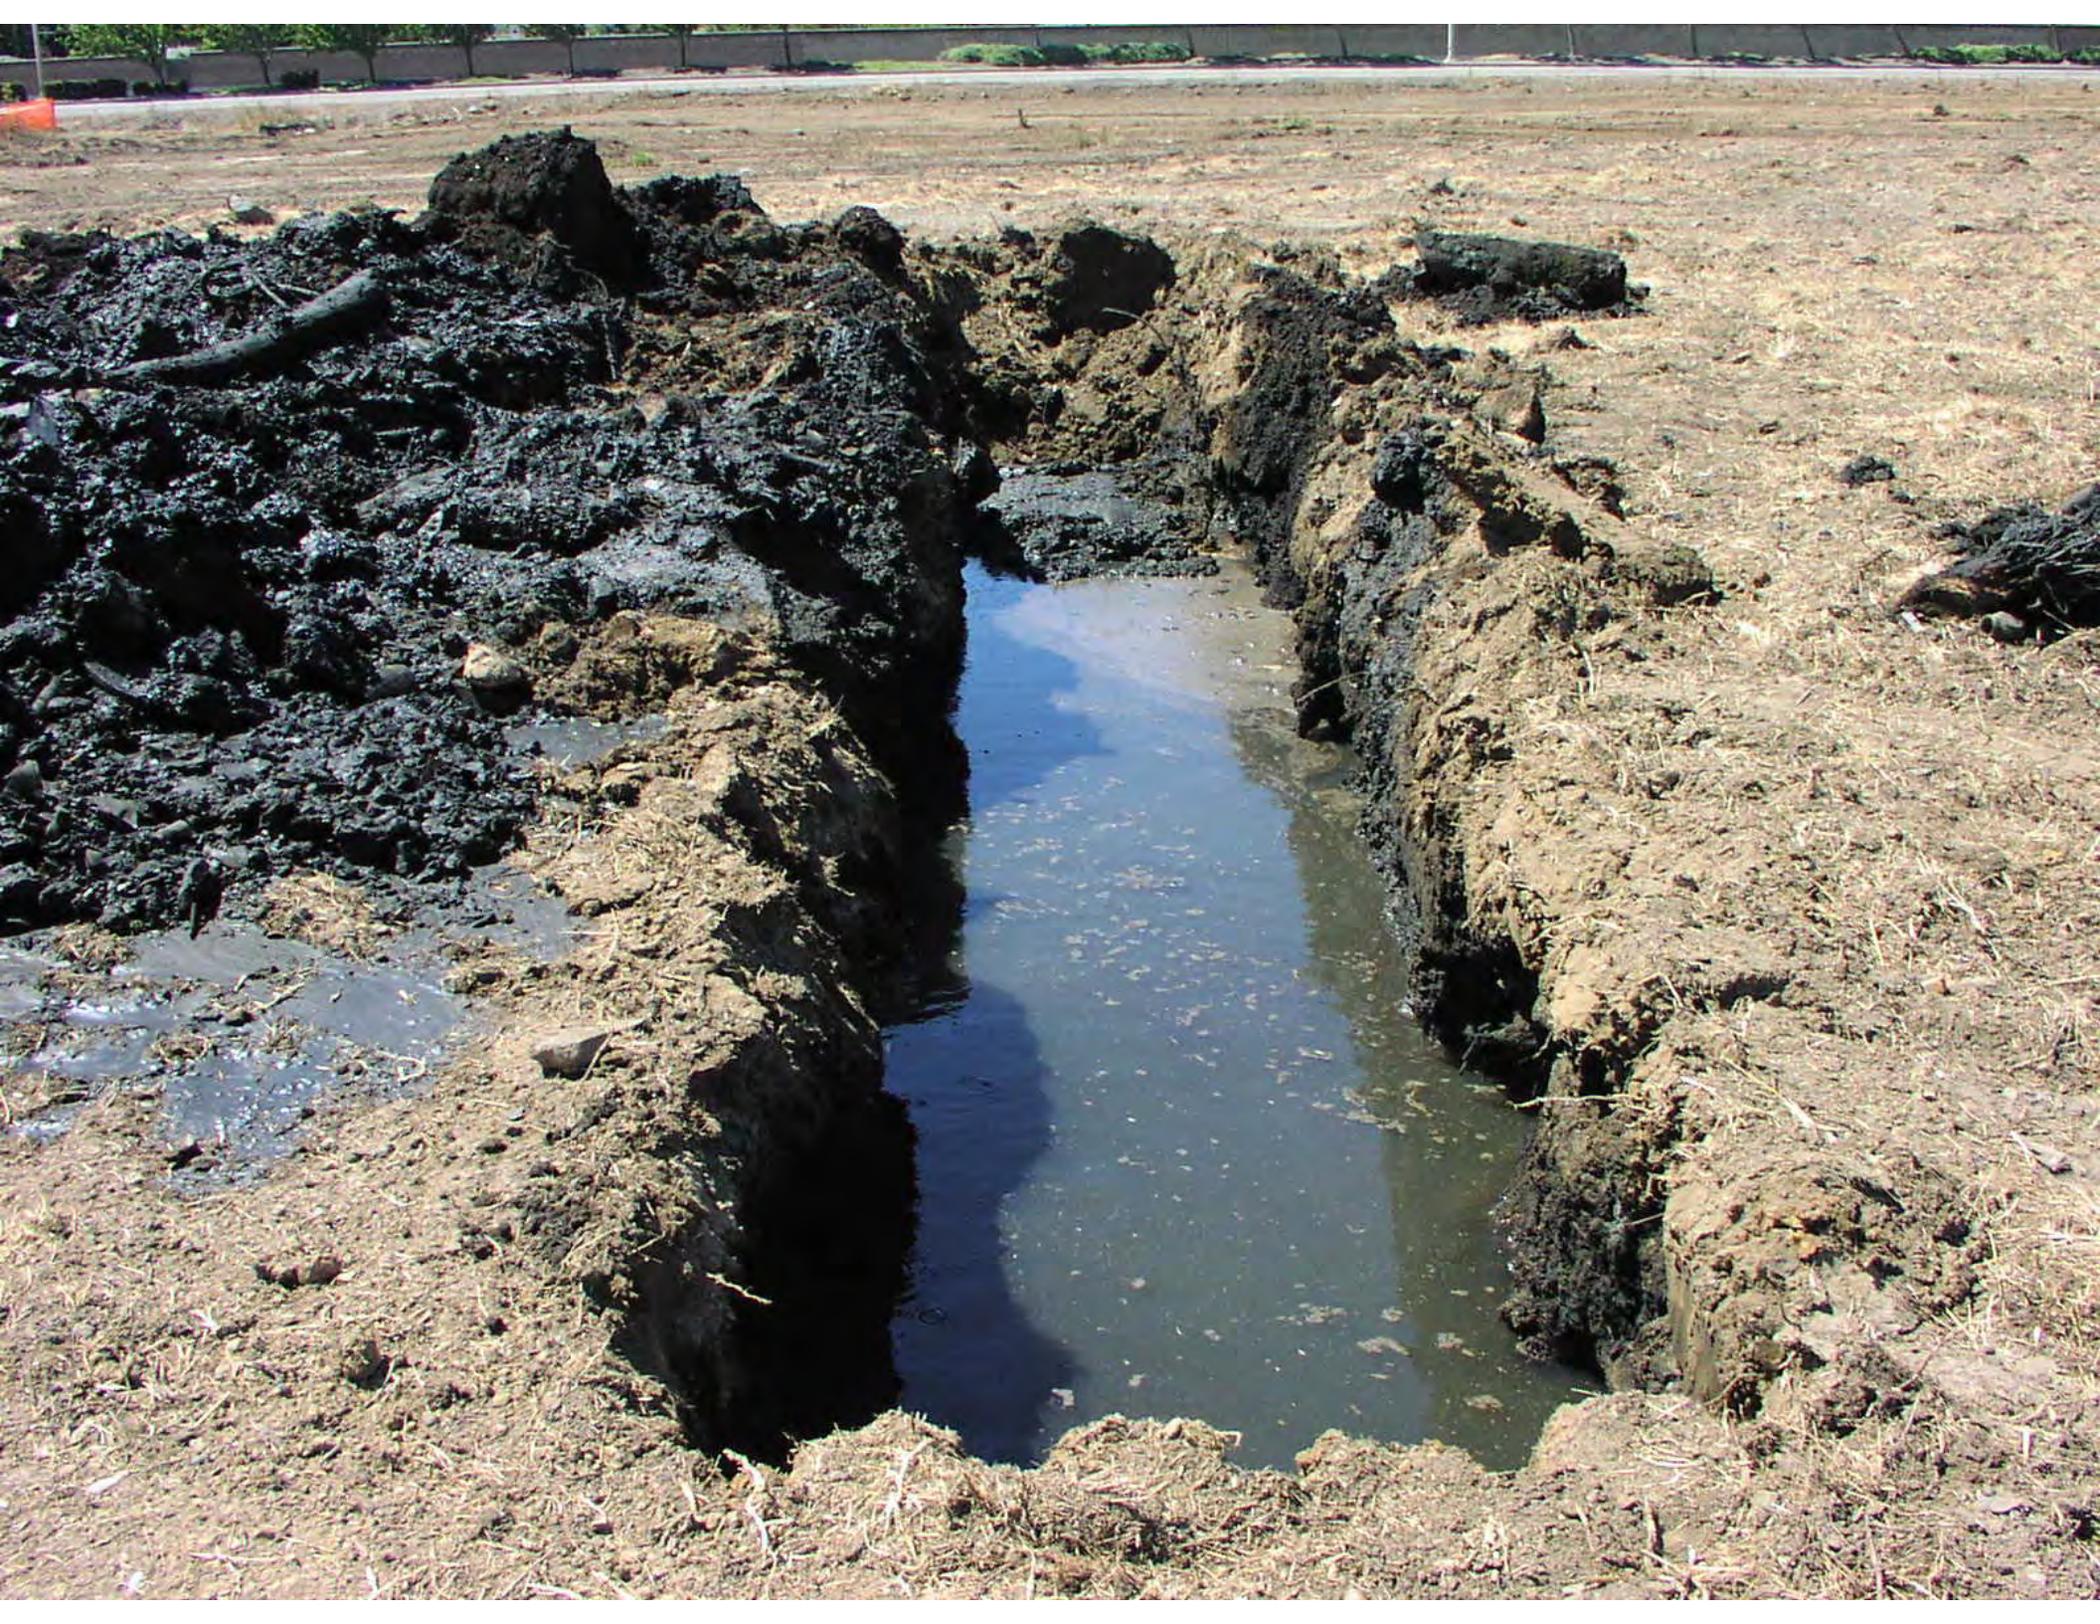
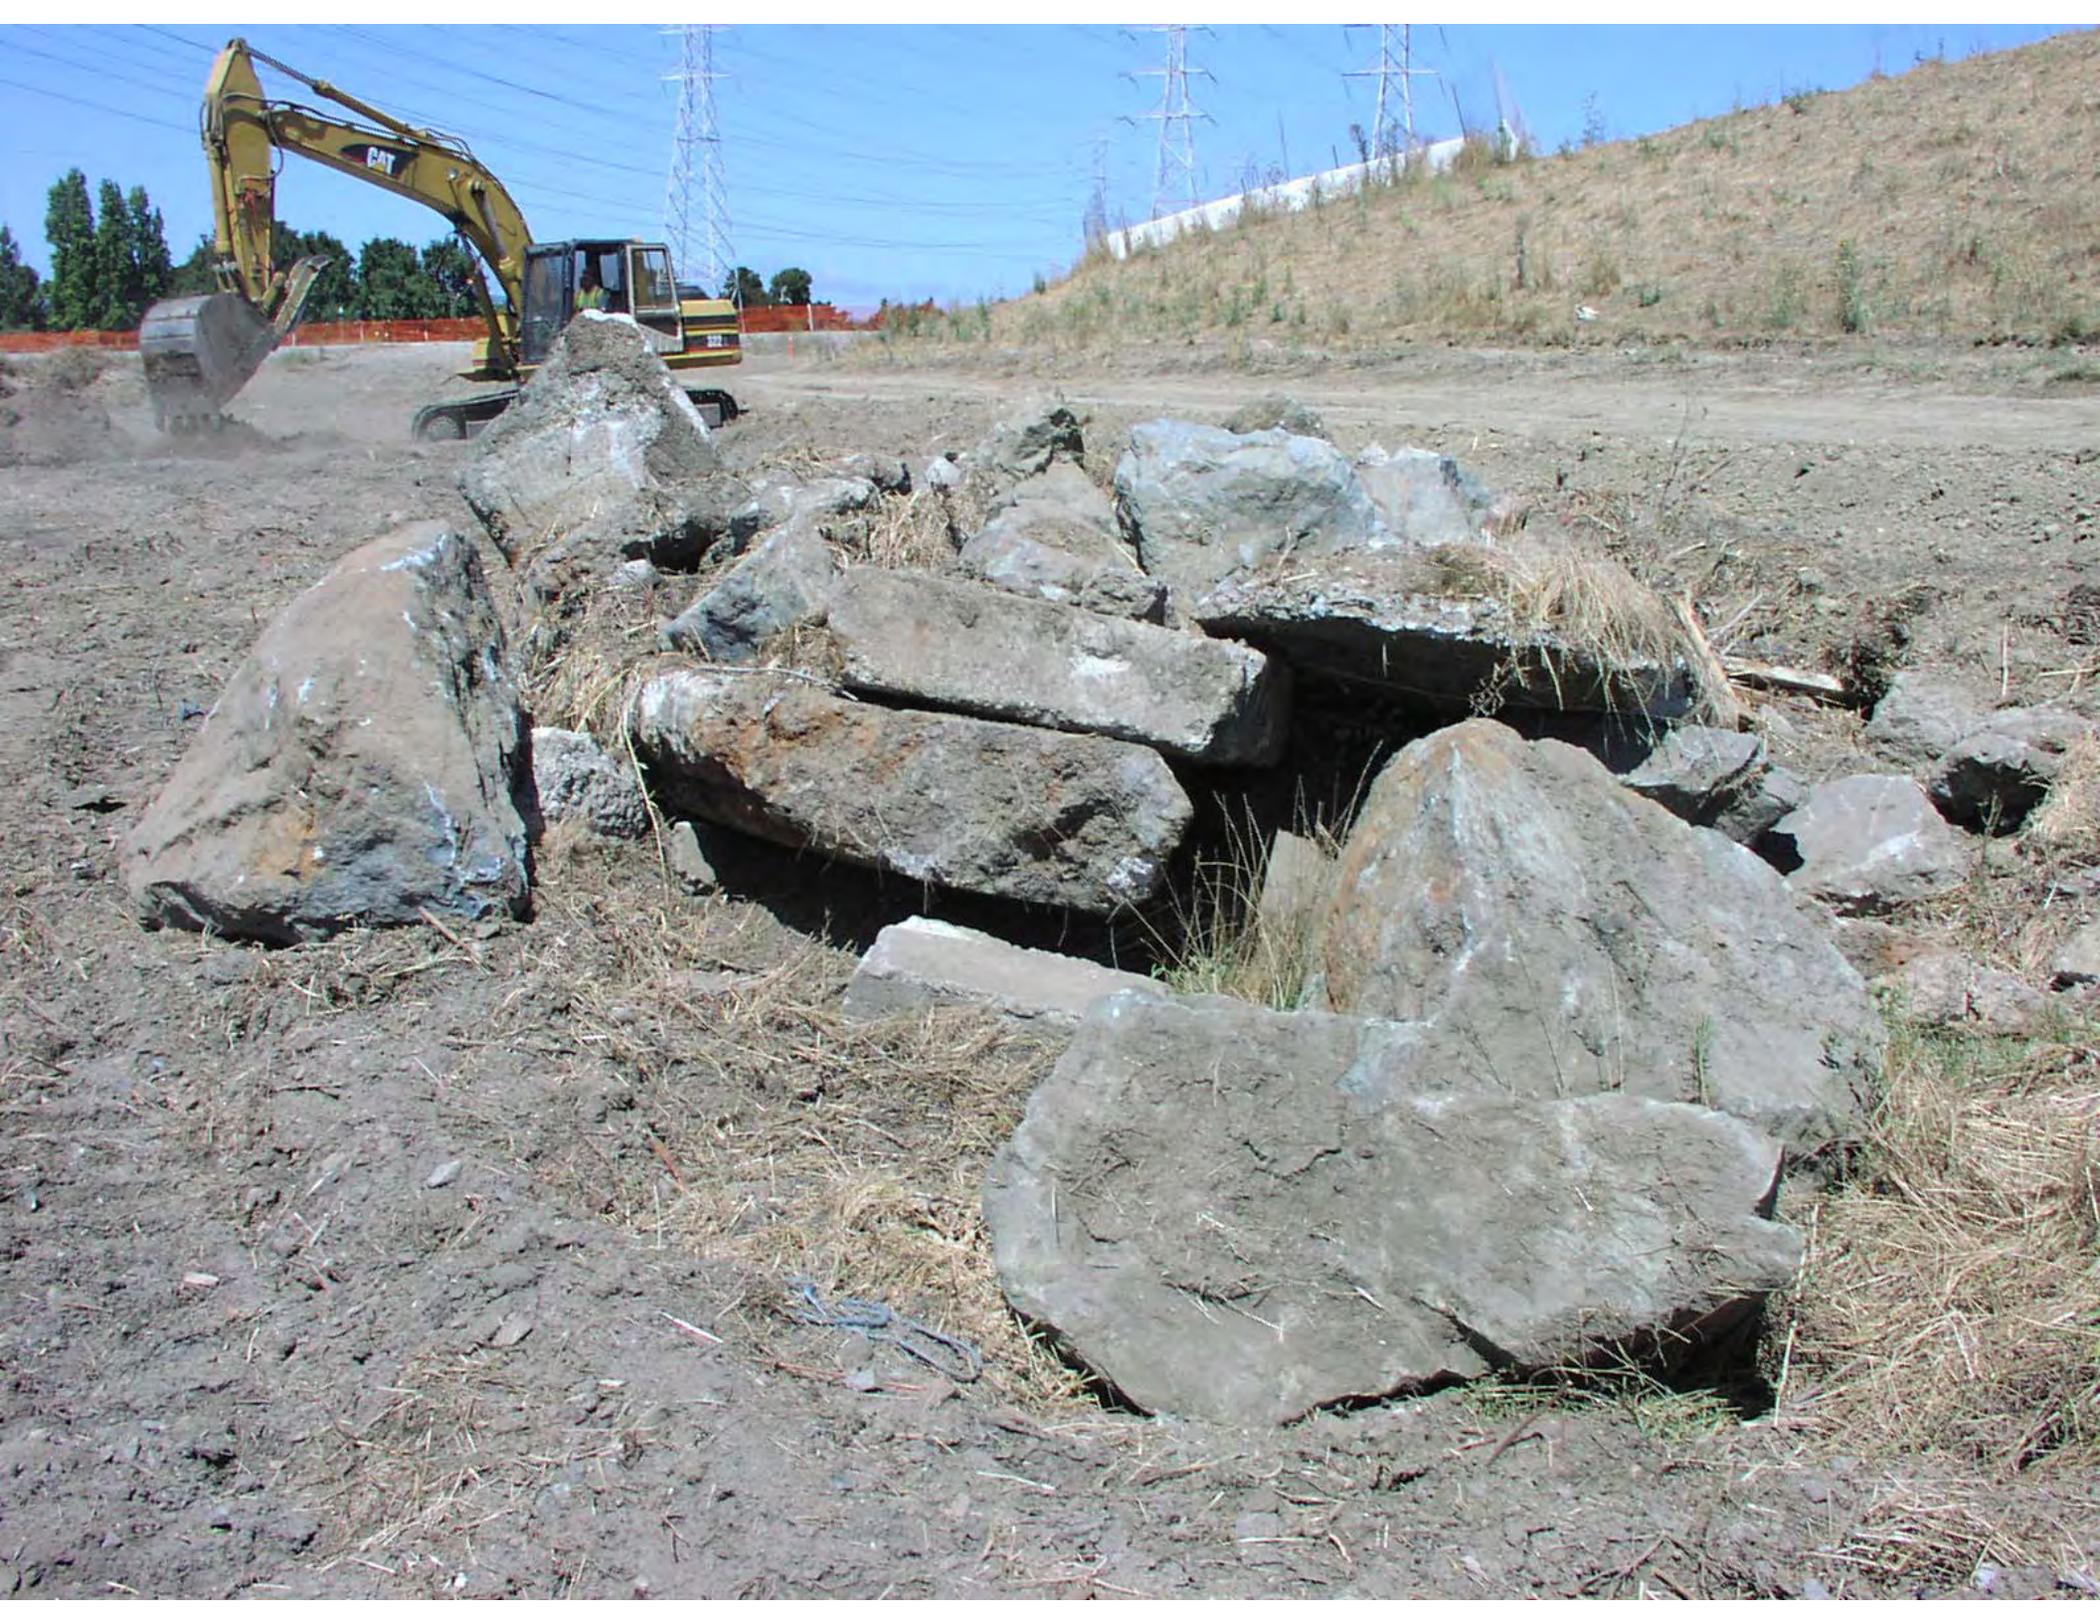
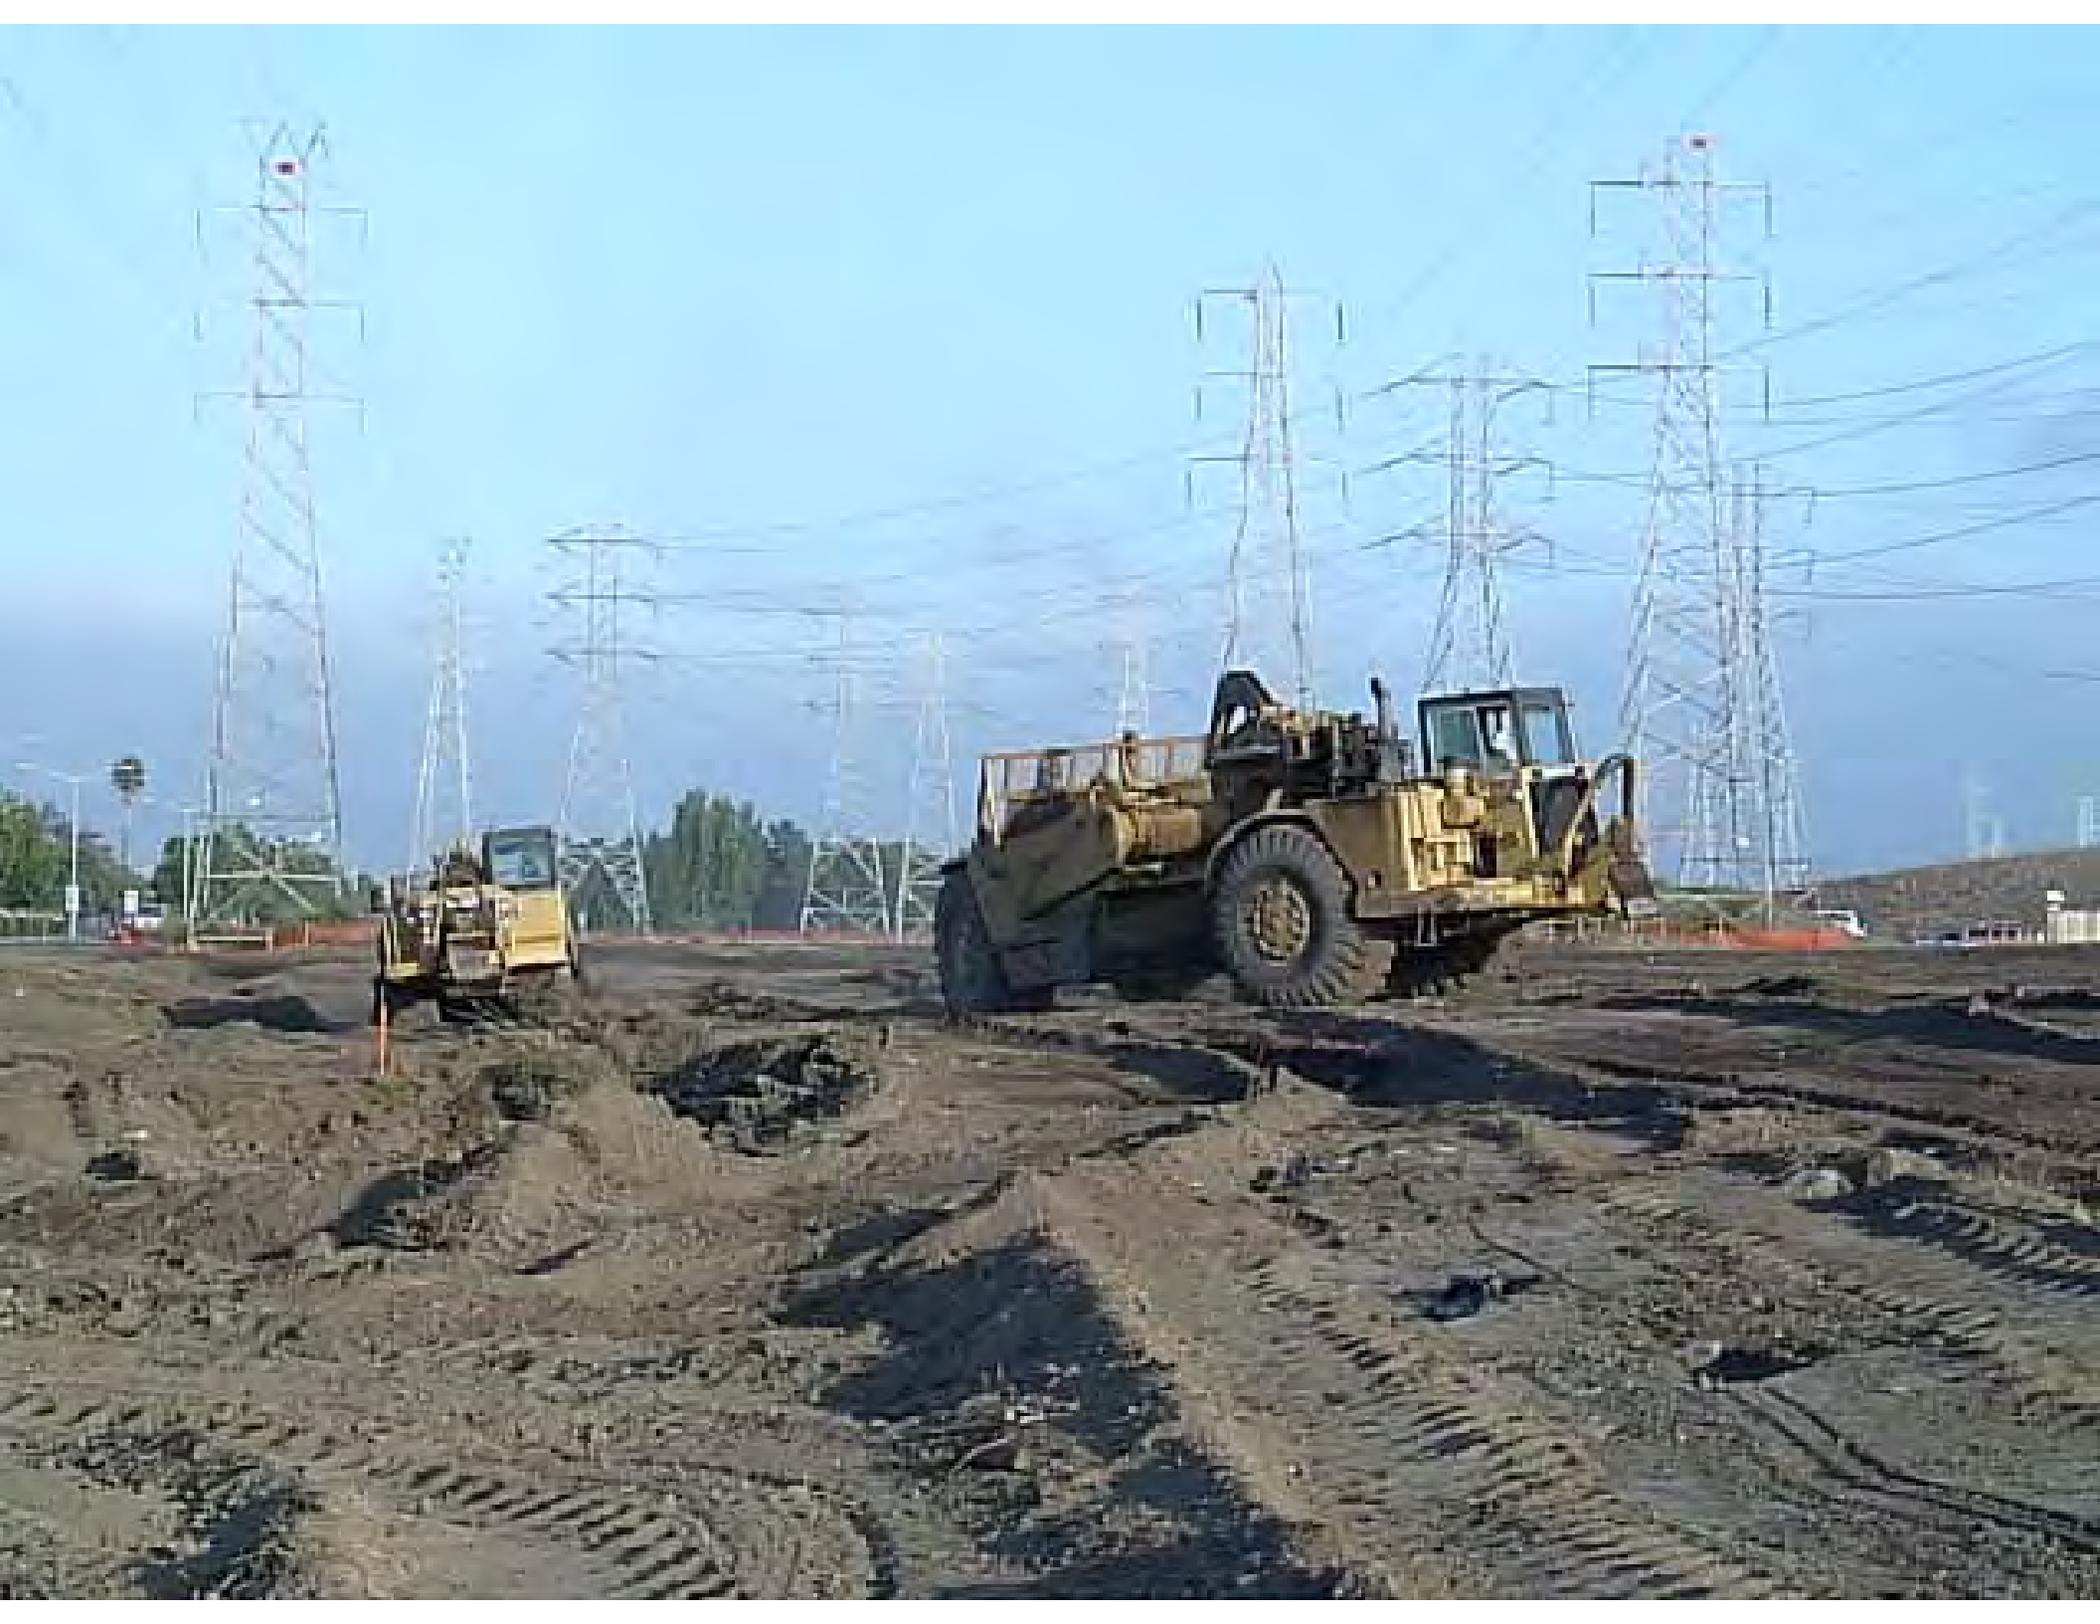
Wetlands Construction

- Dug out 70,000 CY landfill material
- Construction debris & logs
- Composted vegetation
- Very wet conditions
- Drainage features
- Stockpiled material for building landfill cap
 - Exploration
 - Drying
 - Segregation
