**San Mateo Landfill Closure,
Phase II
&
Seal Point Park**

Scope of Work

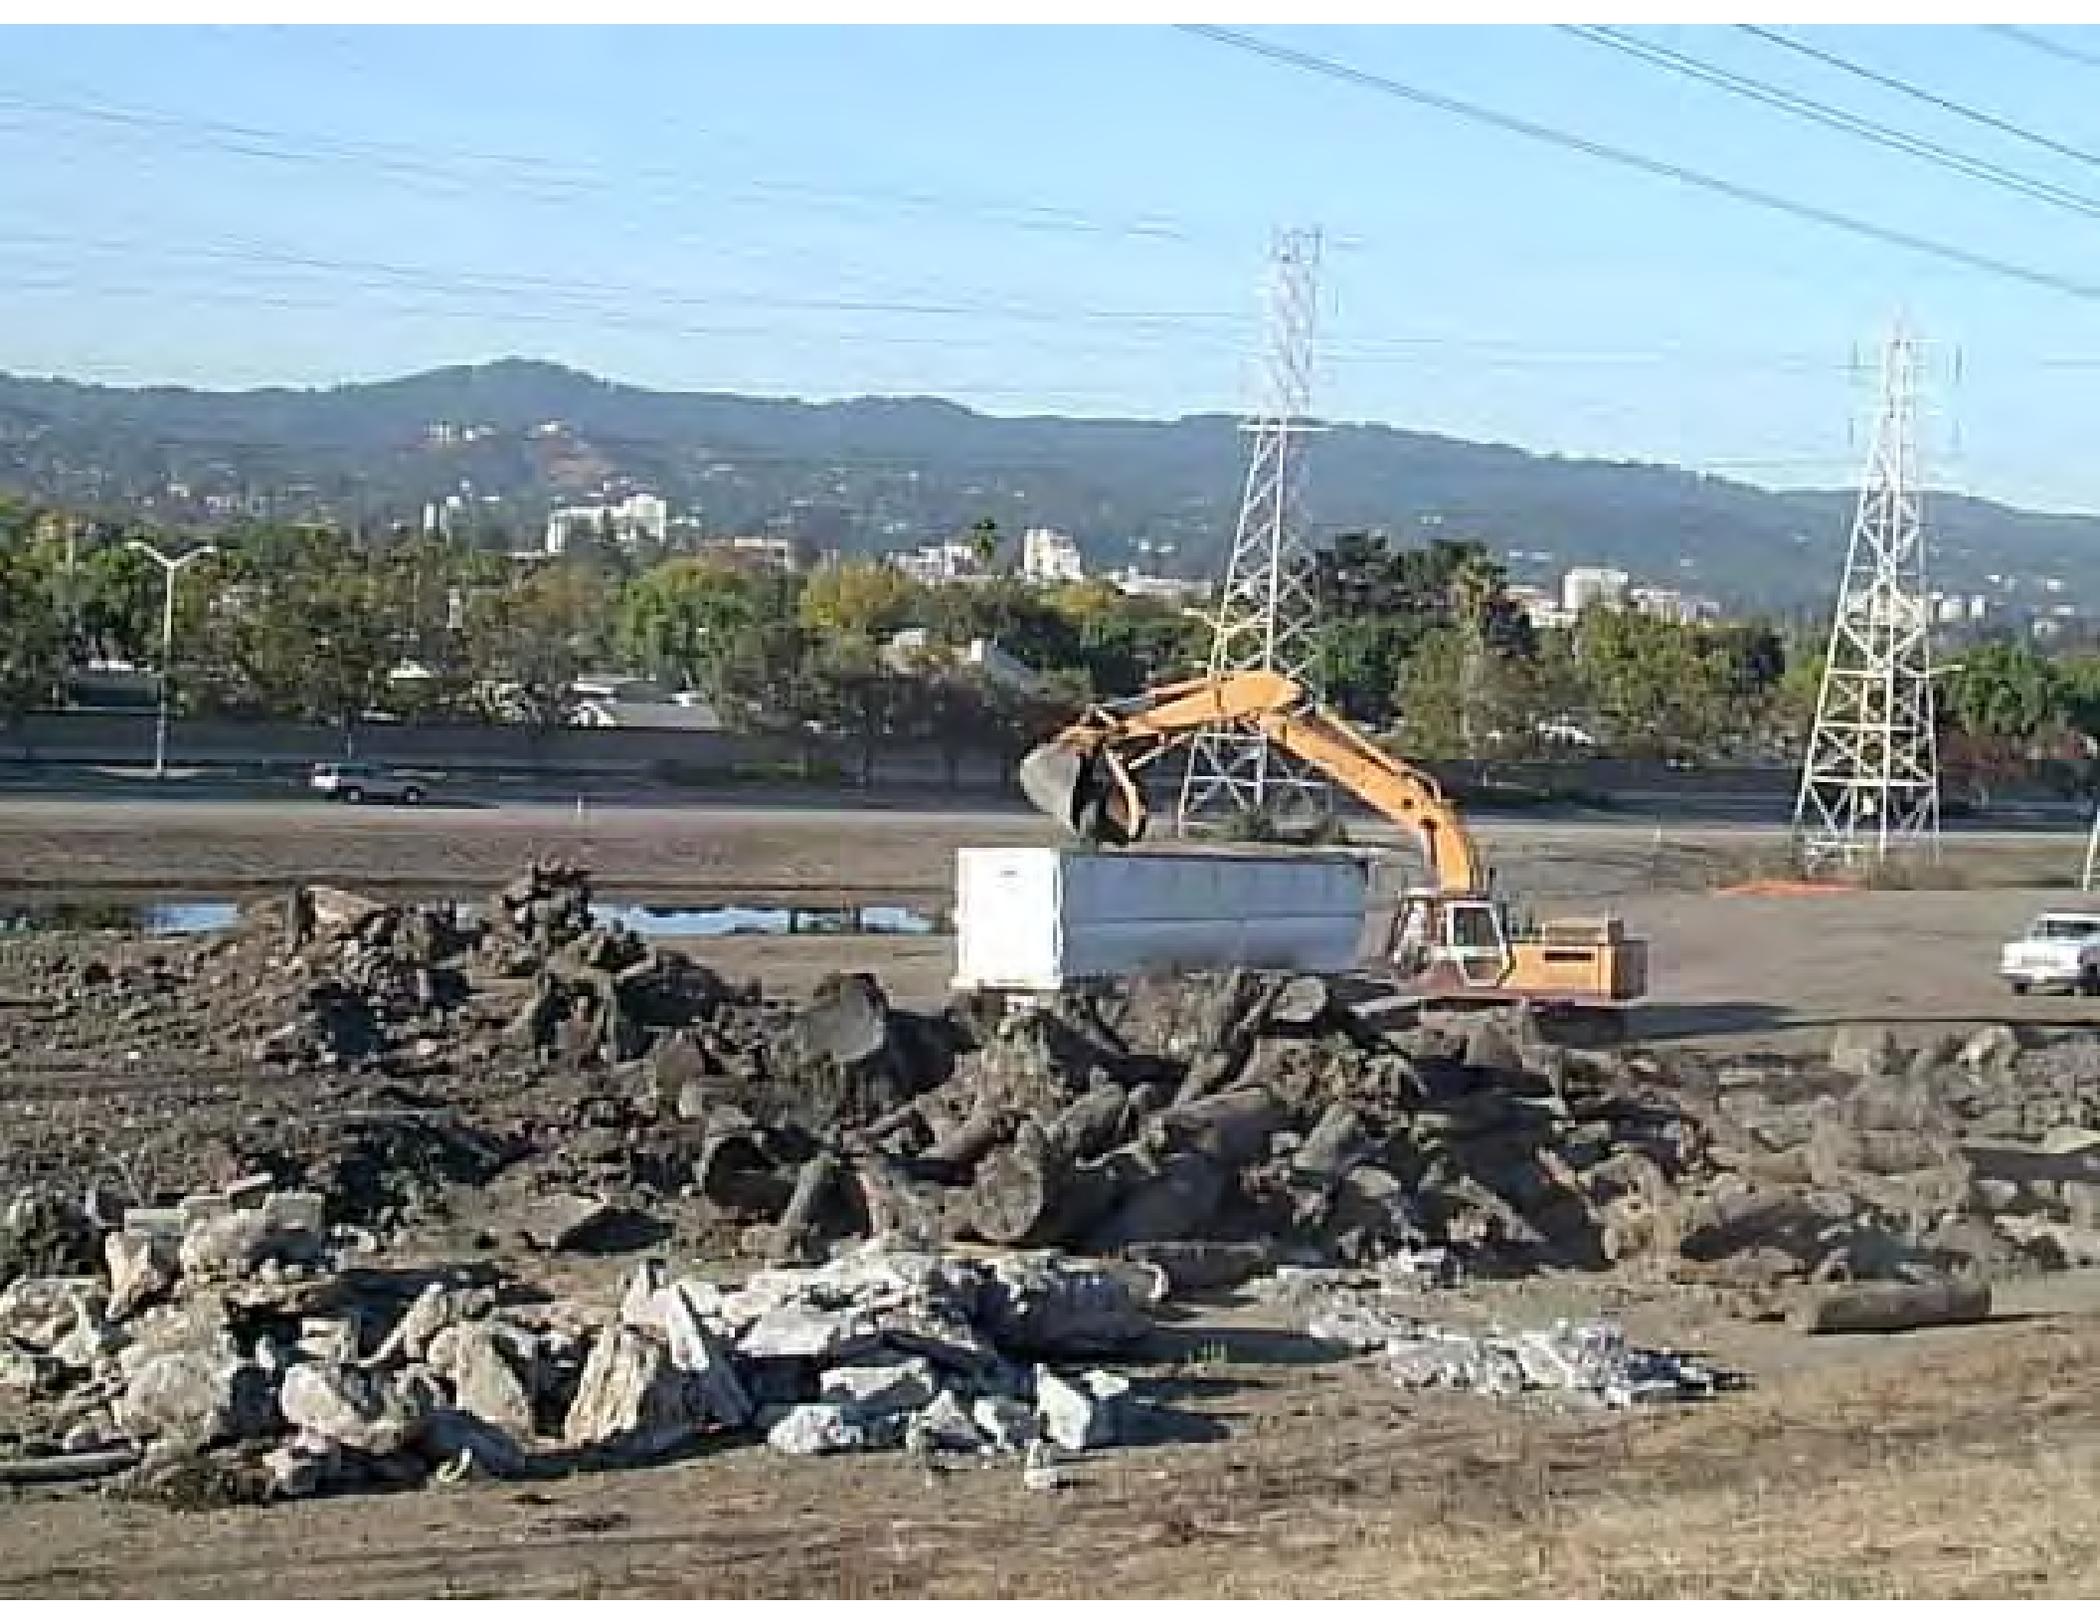
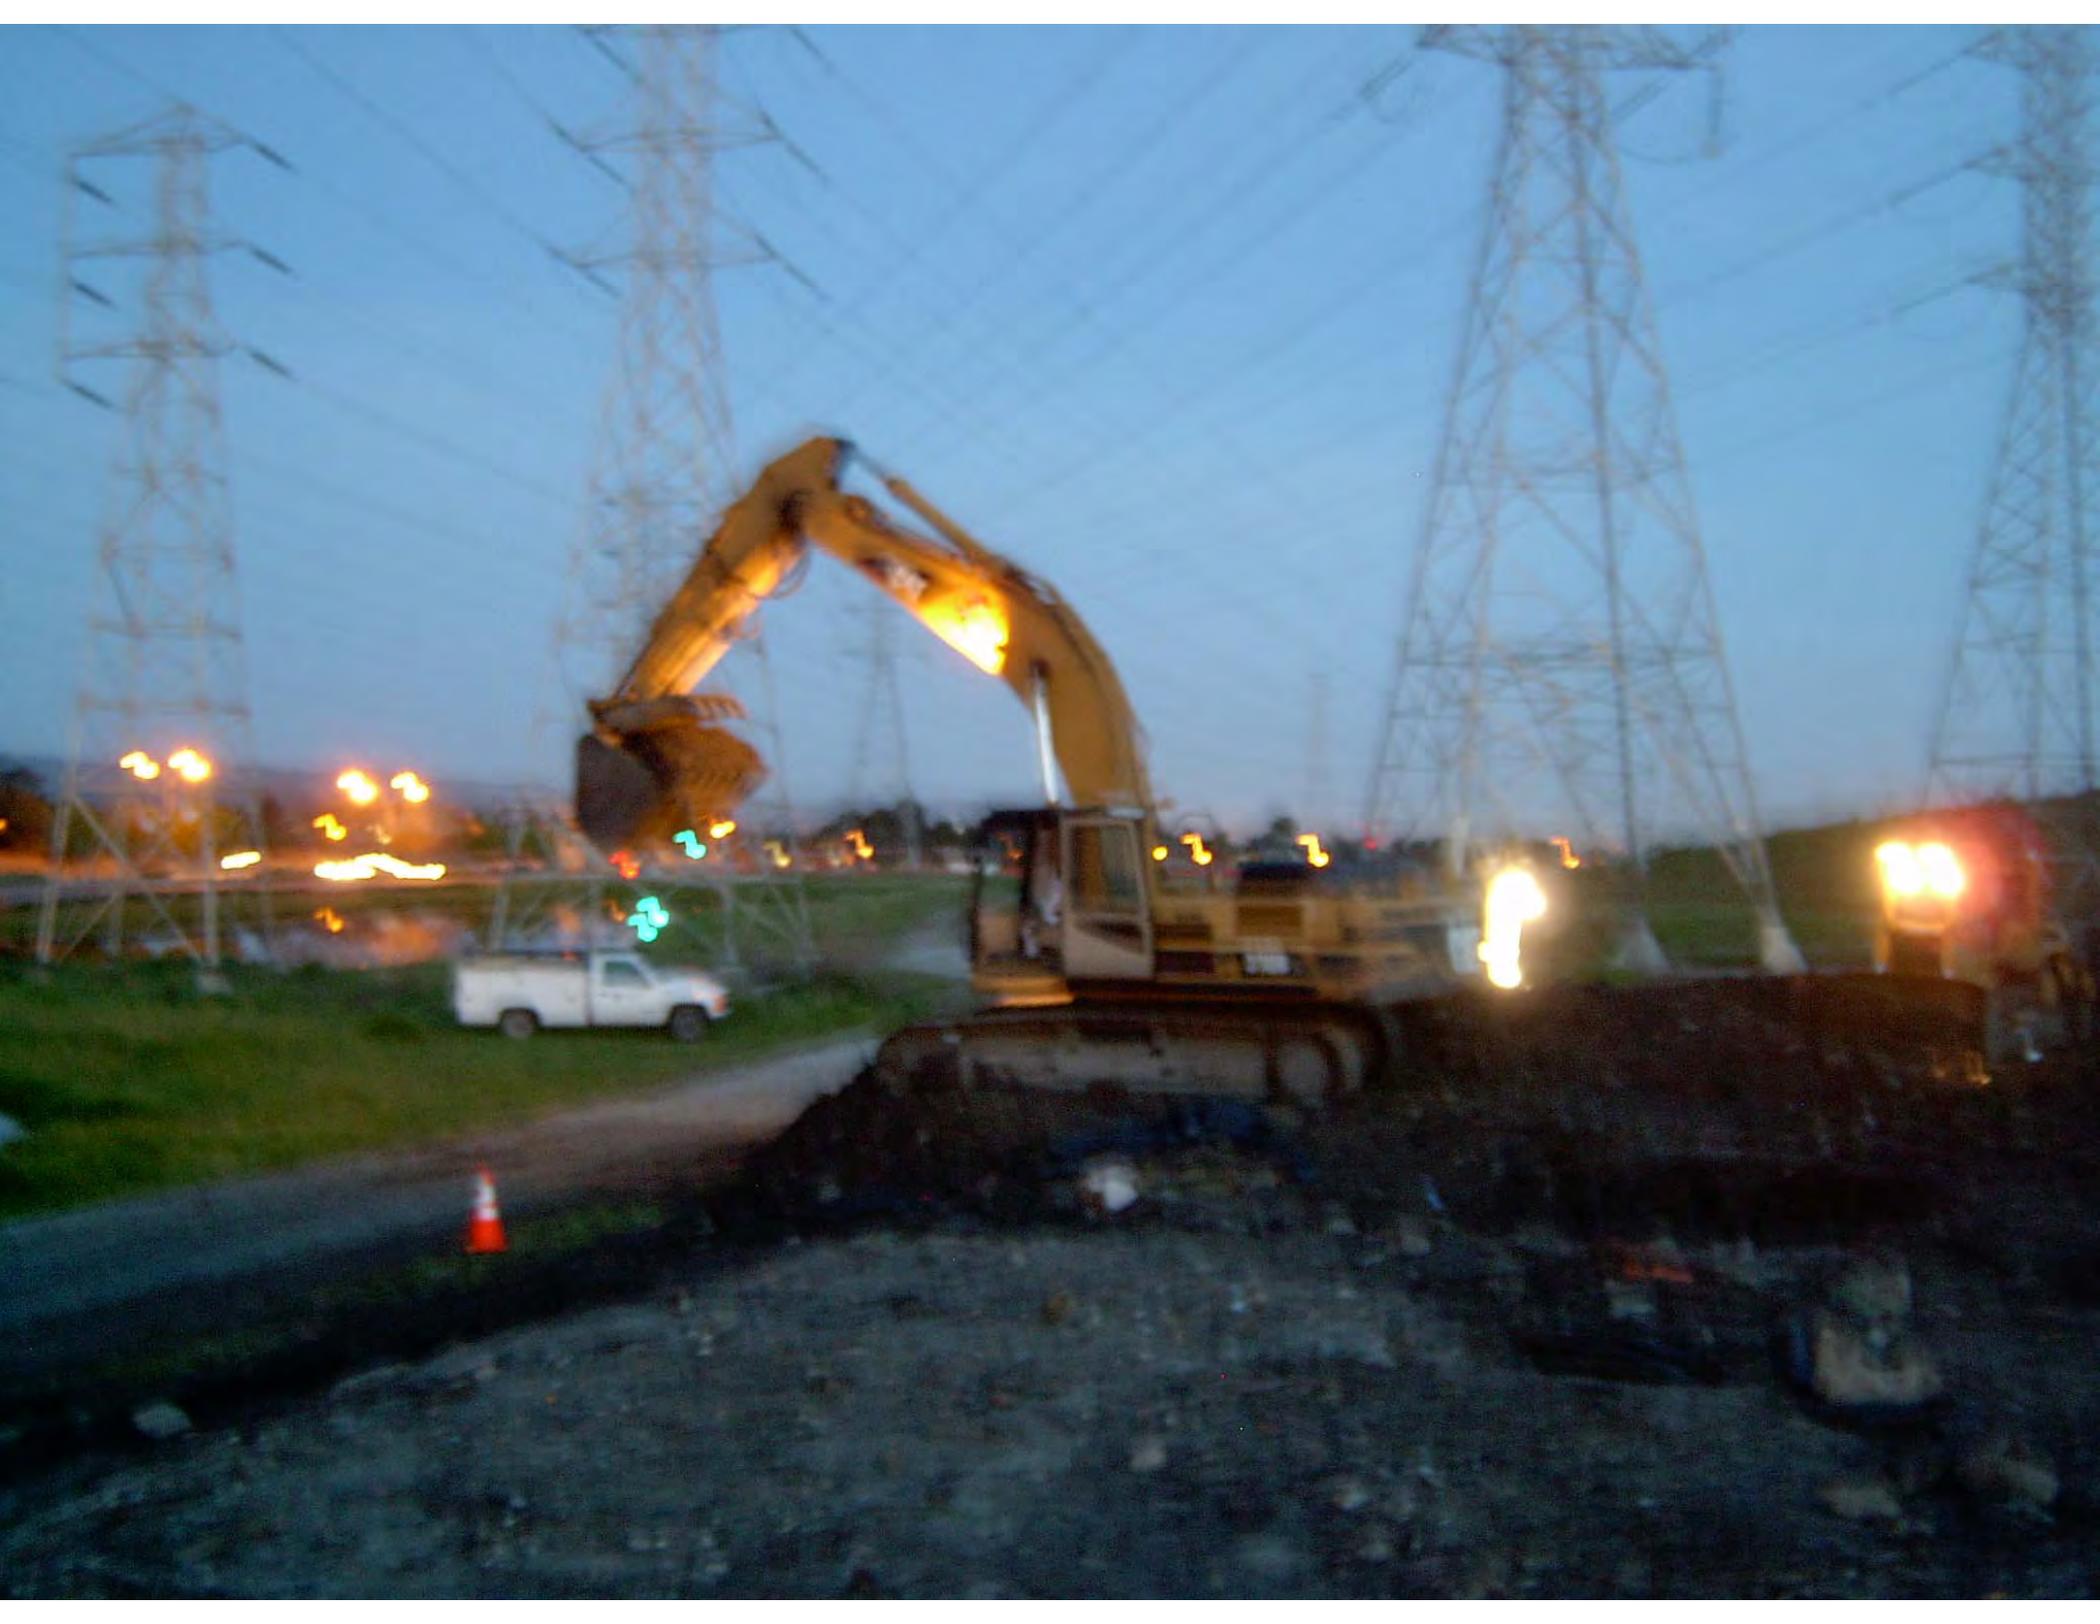
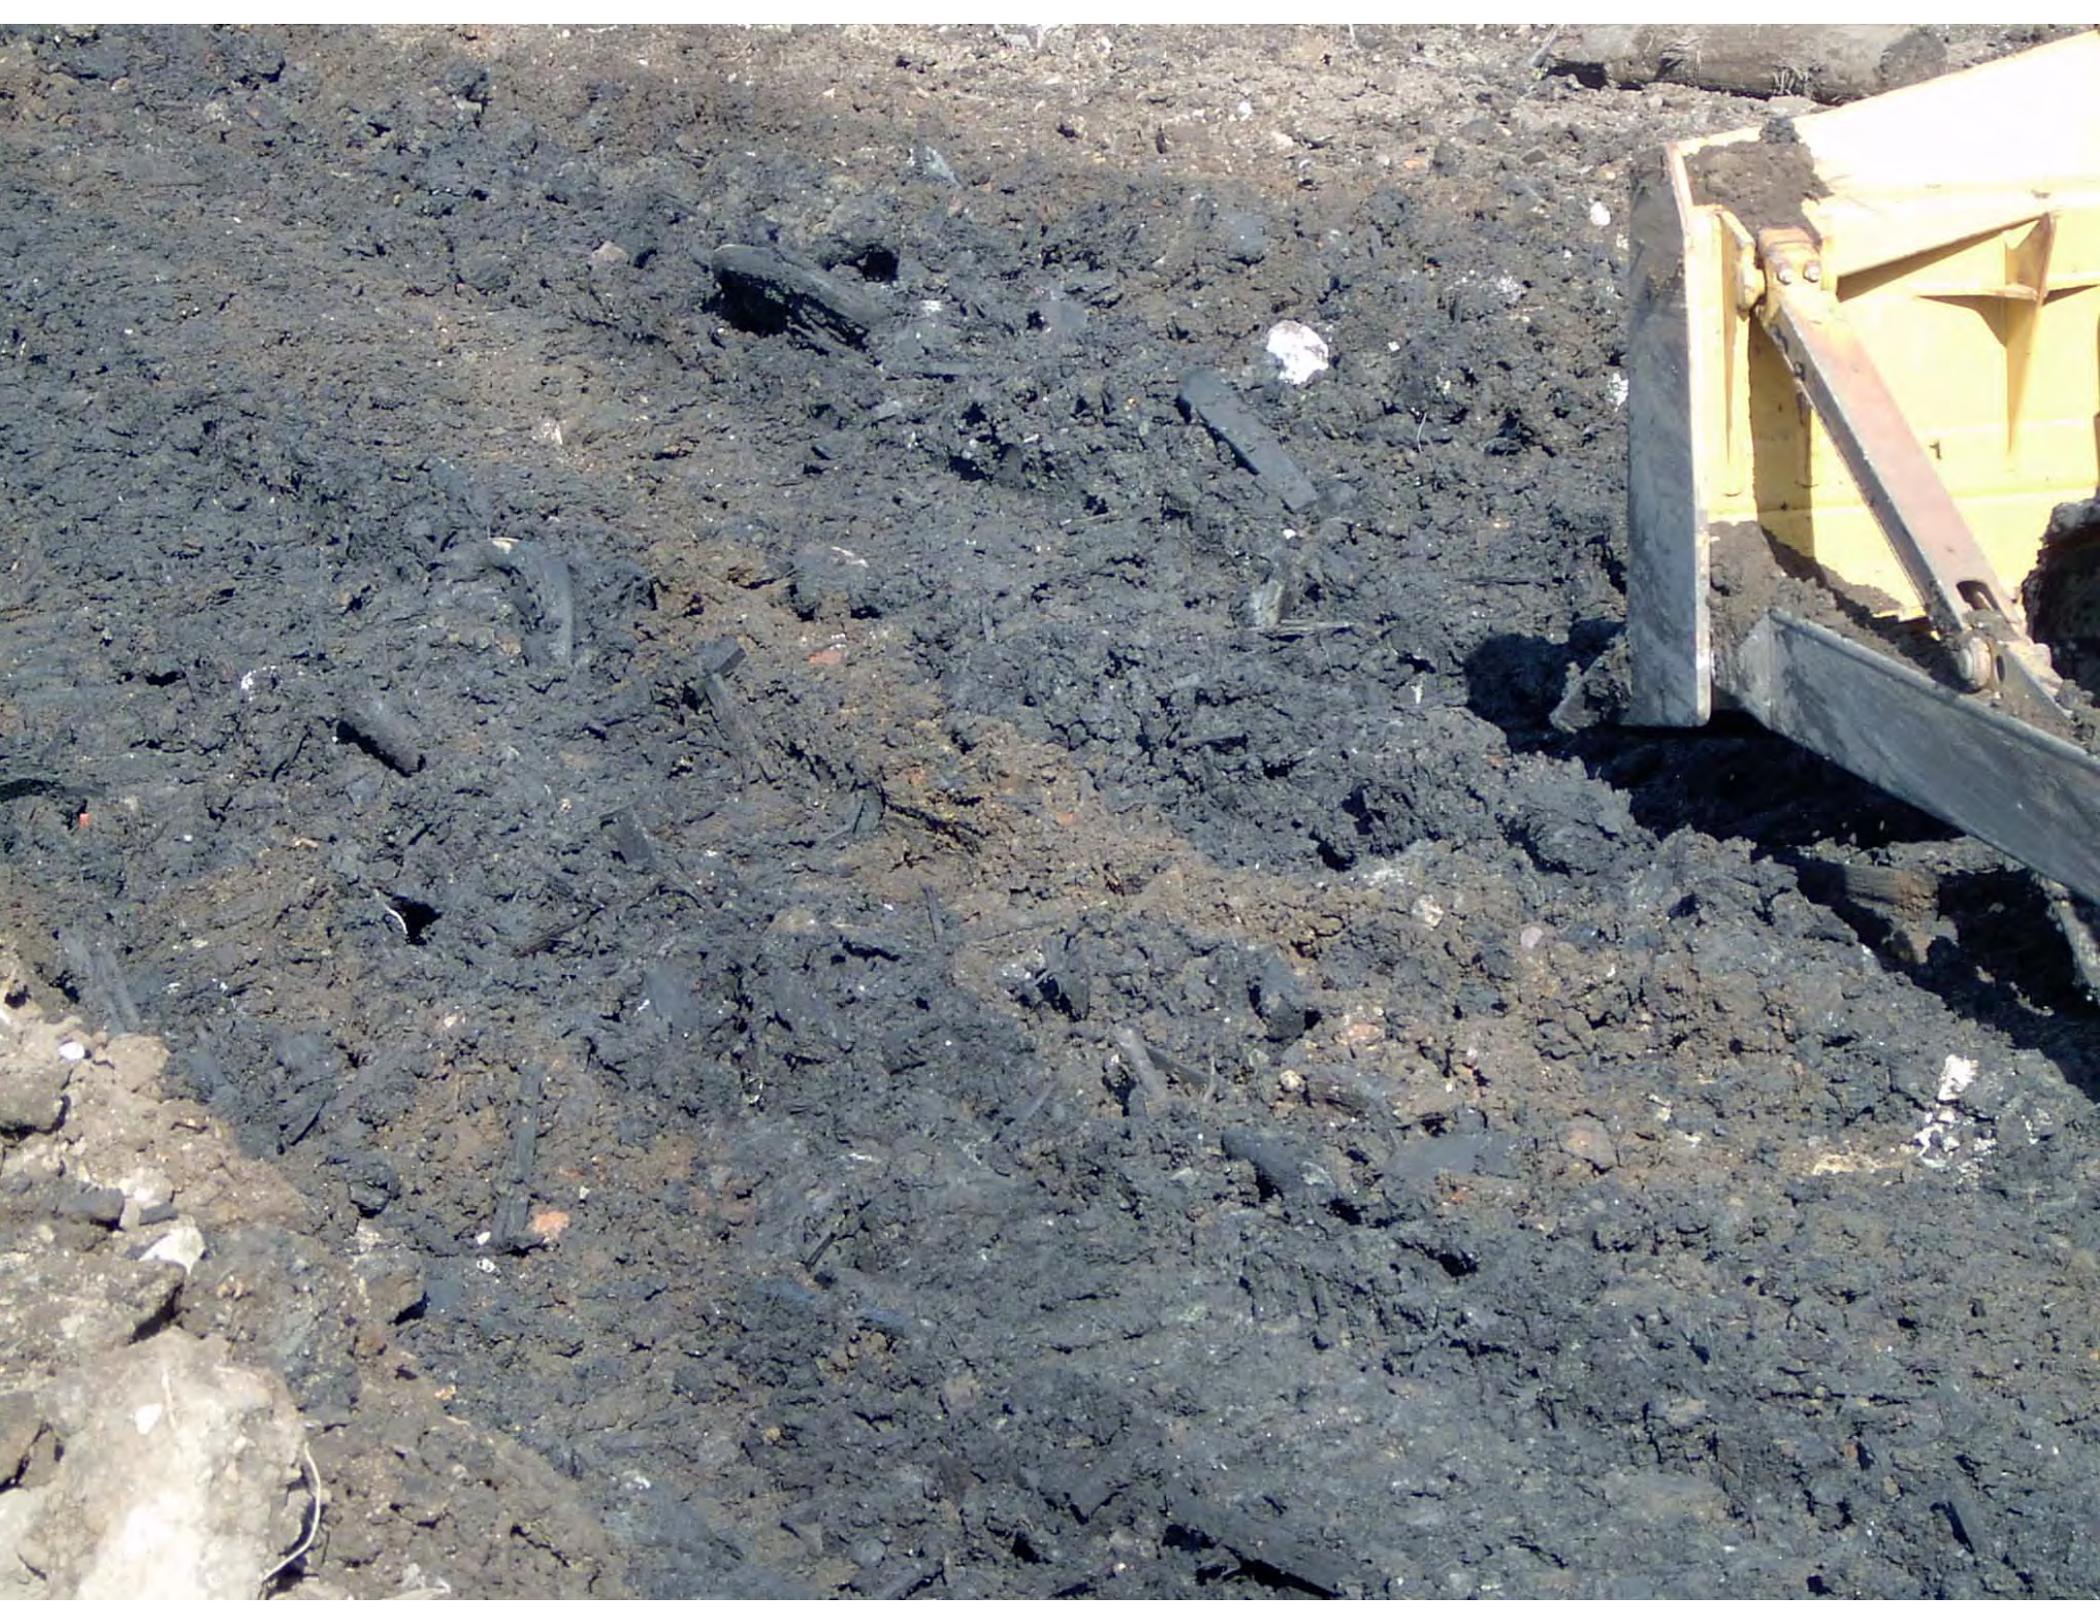
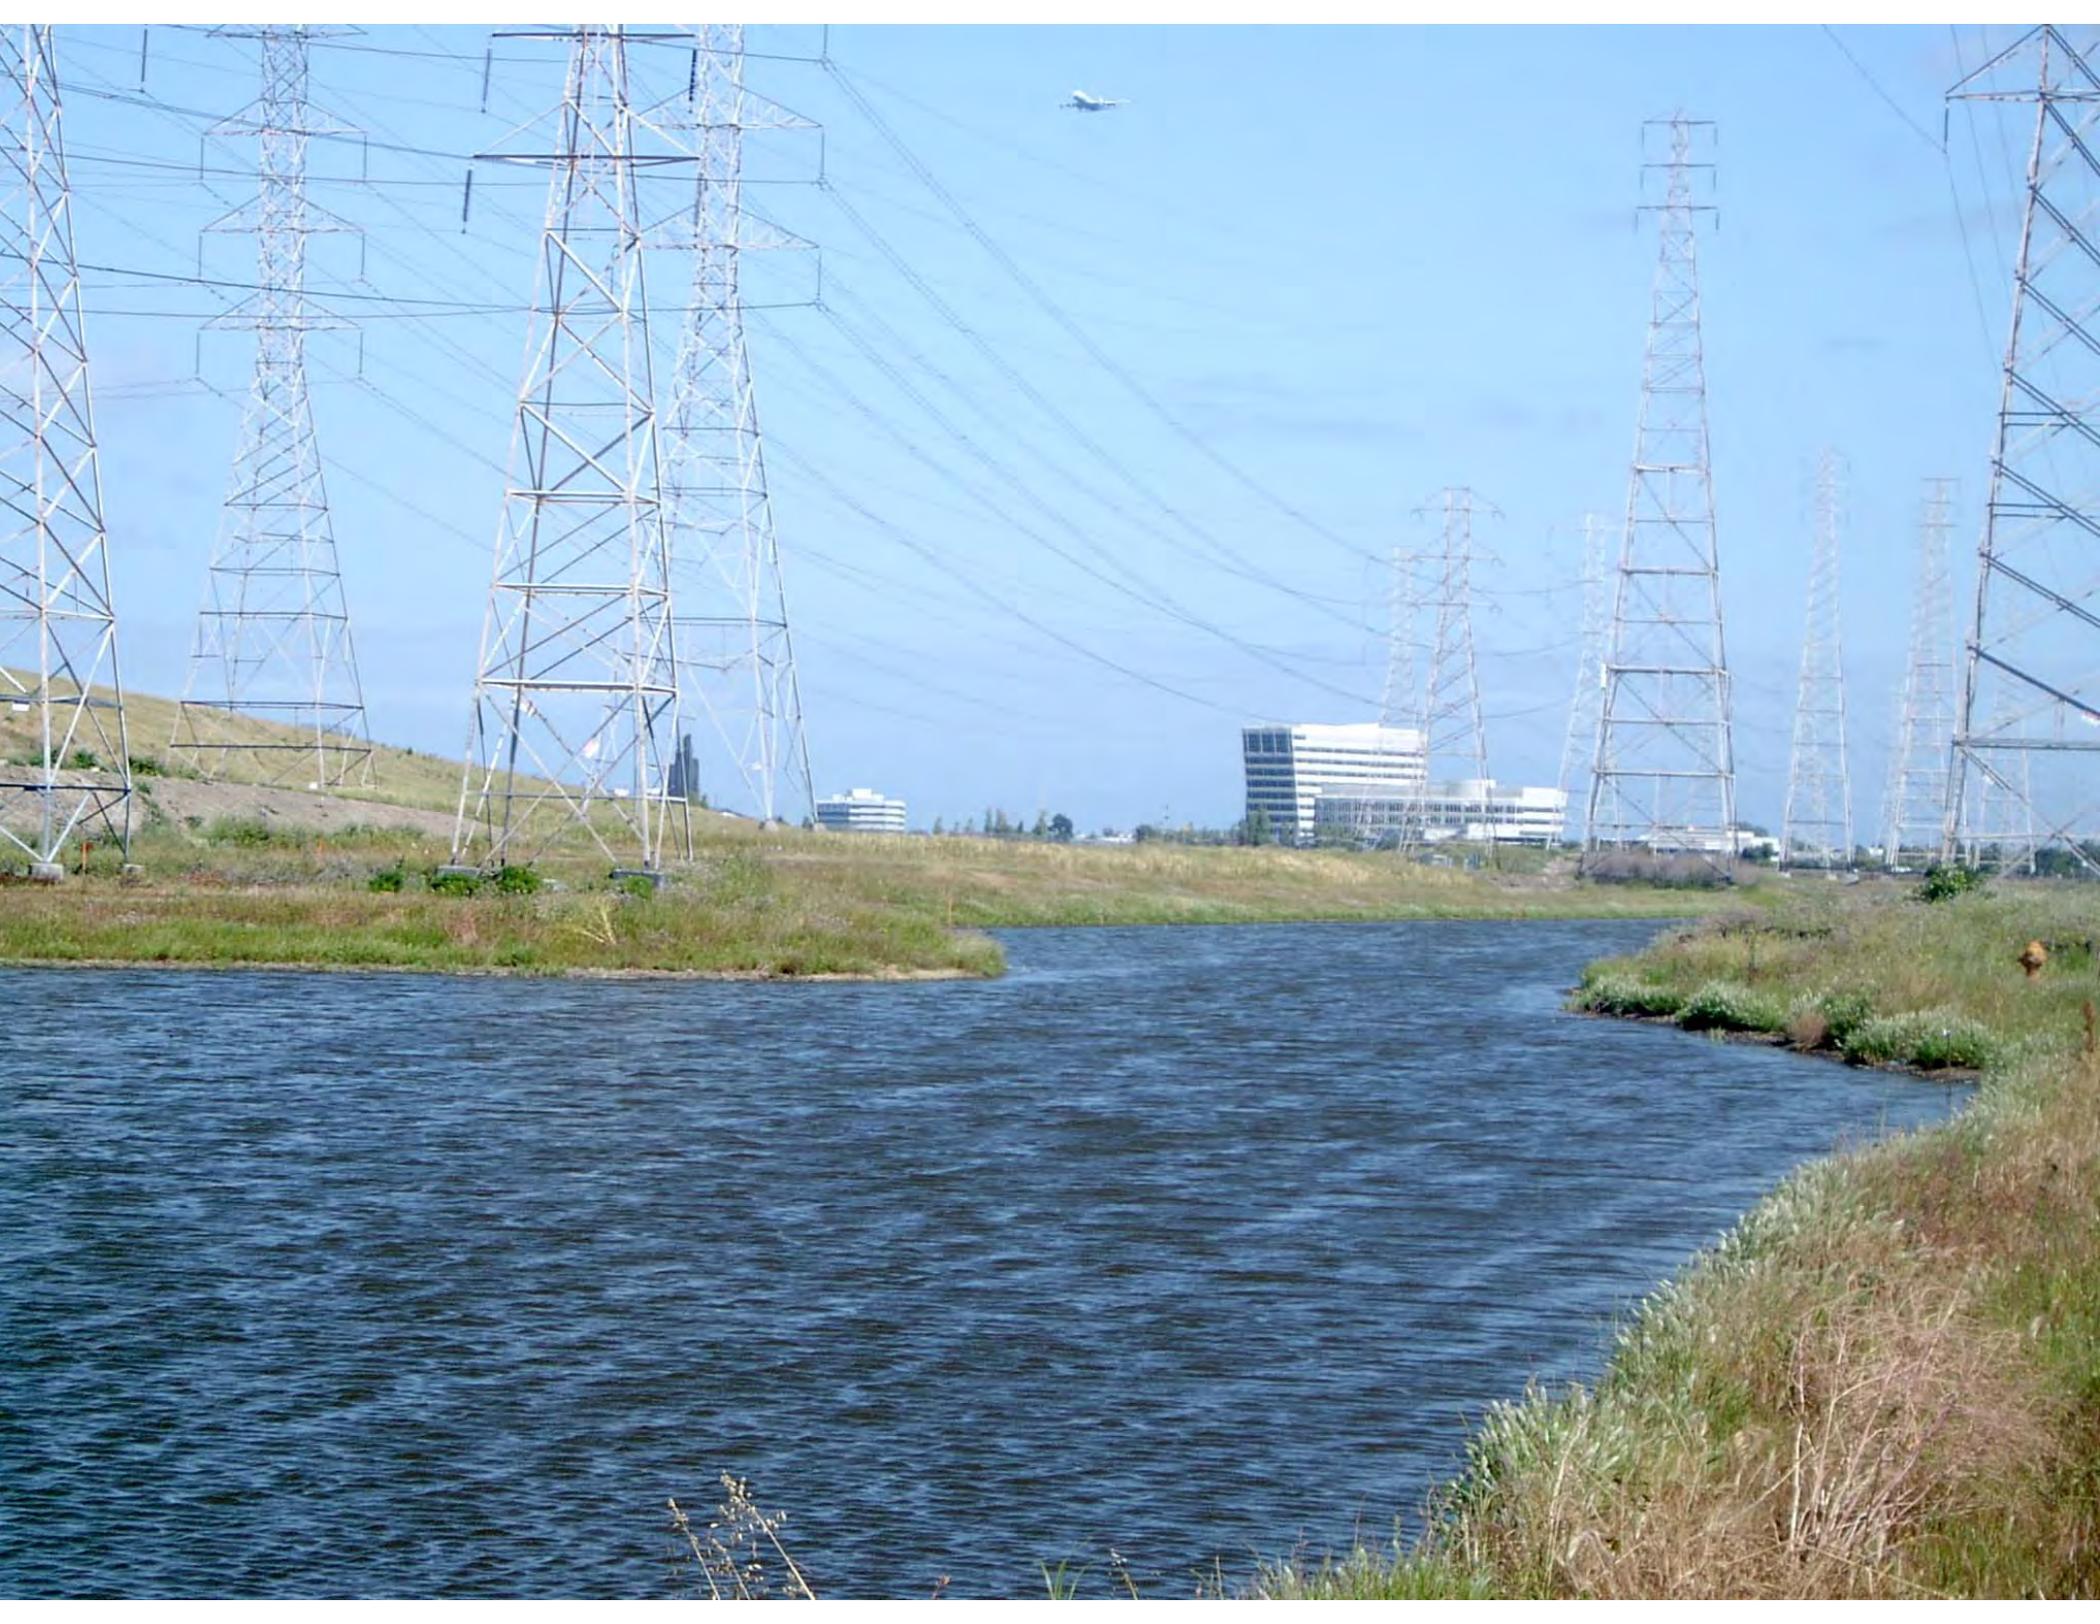
Debris removal

- Logs to Class I site
- Concrete and brick to recycle facility
- Lead-impacted soil to Class III
(CA Hazardous Waste, non-RCRA)
