**San Mateo Landfill Closure,
Phase II
&
Seal Point Park**

Scope of Work

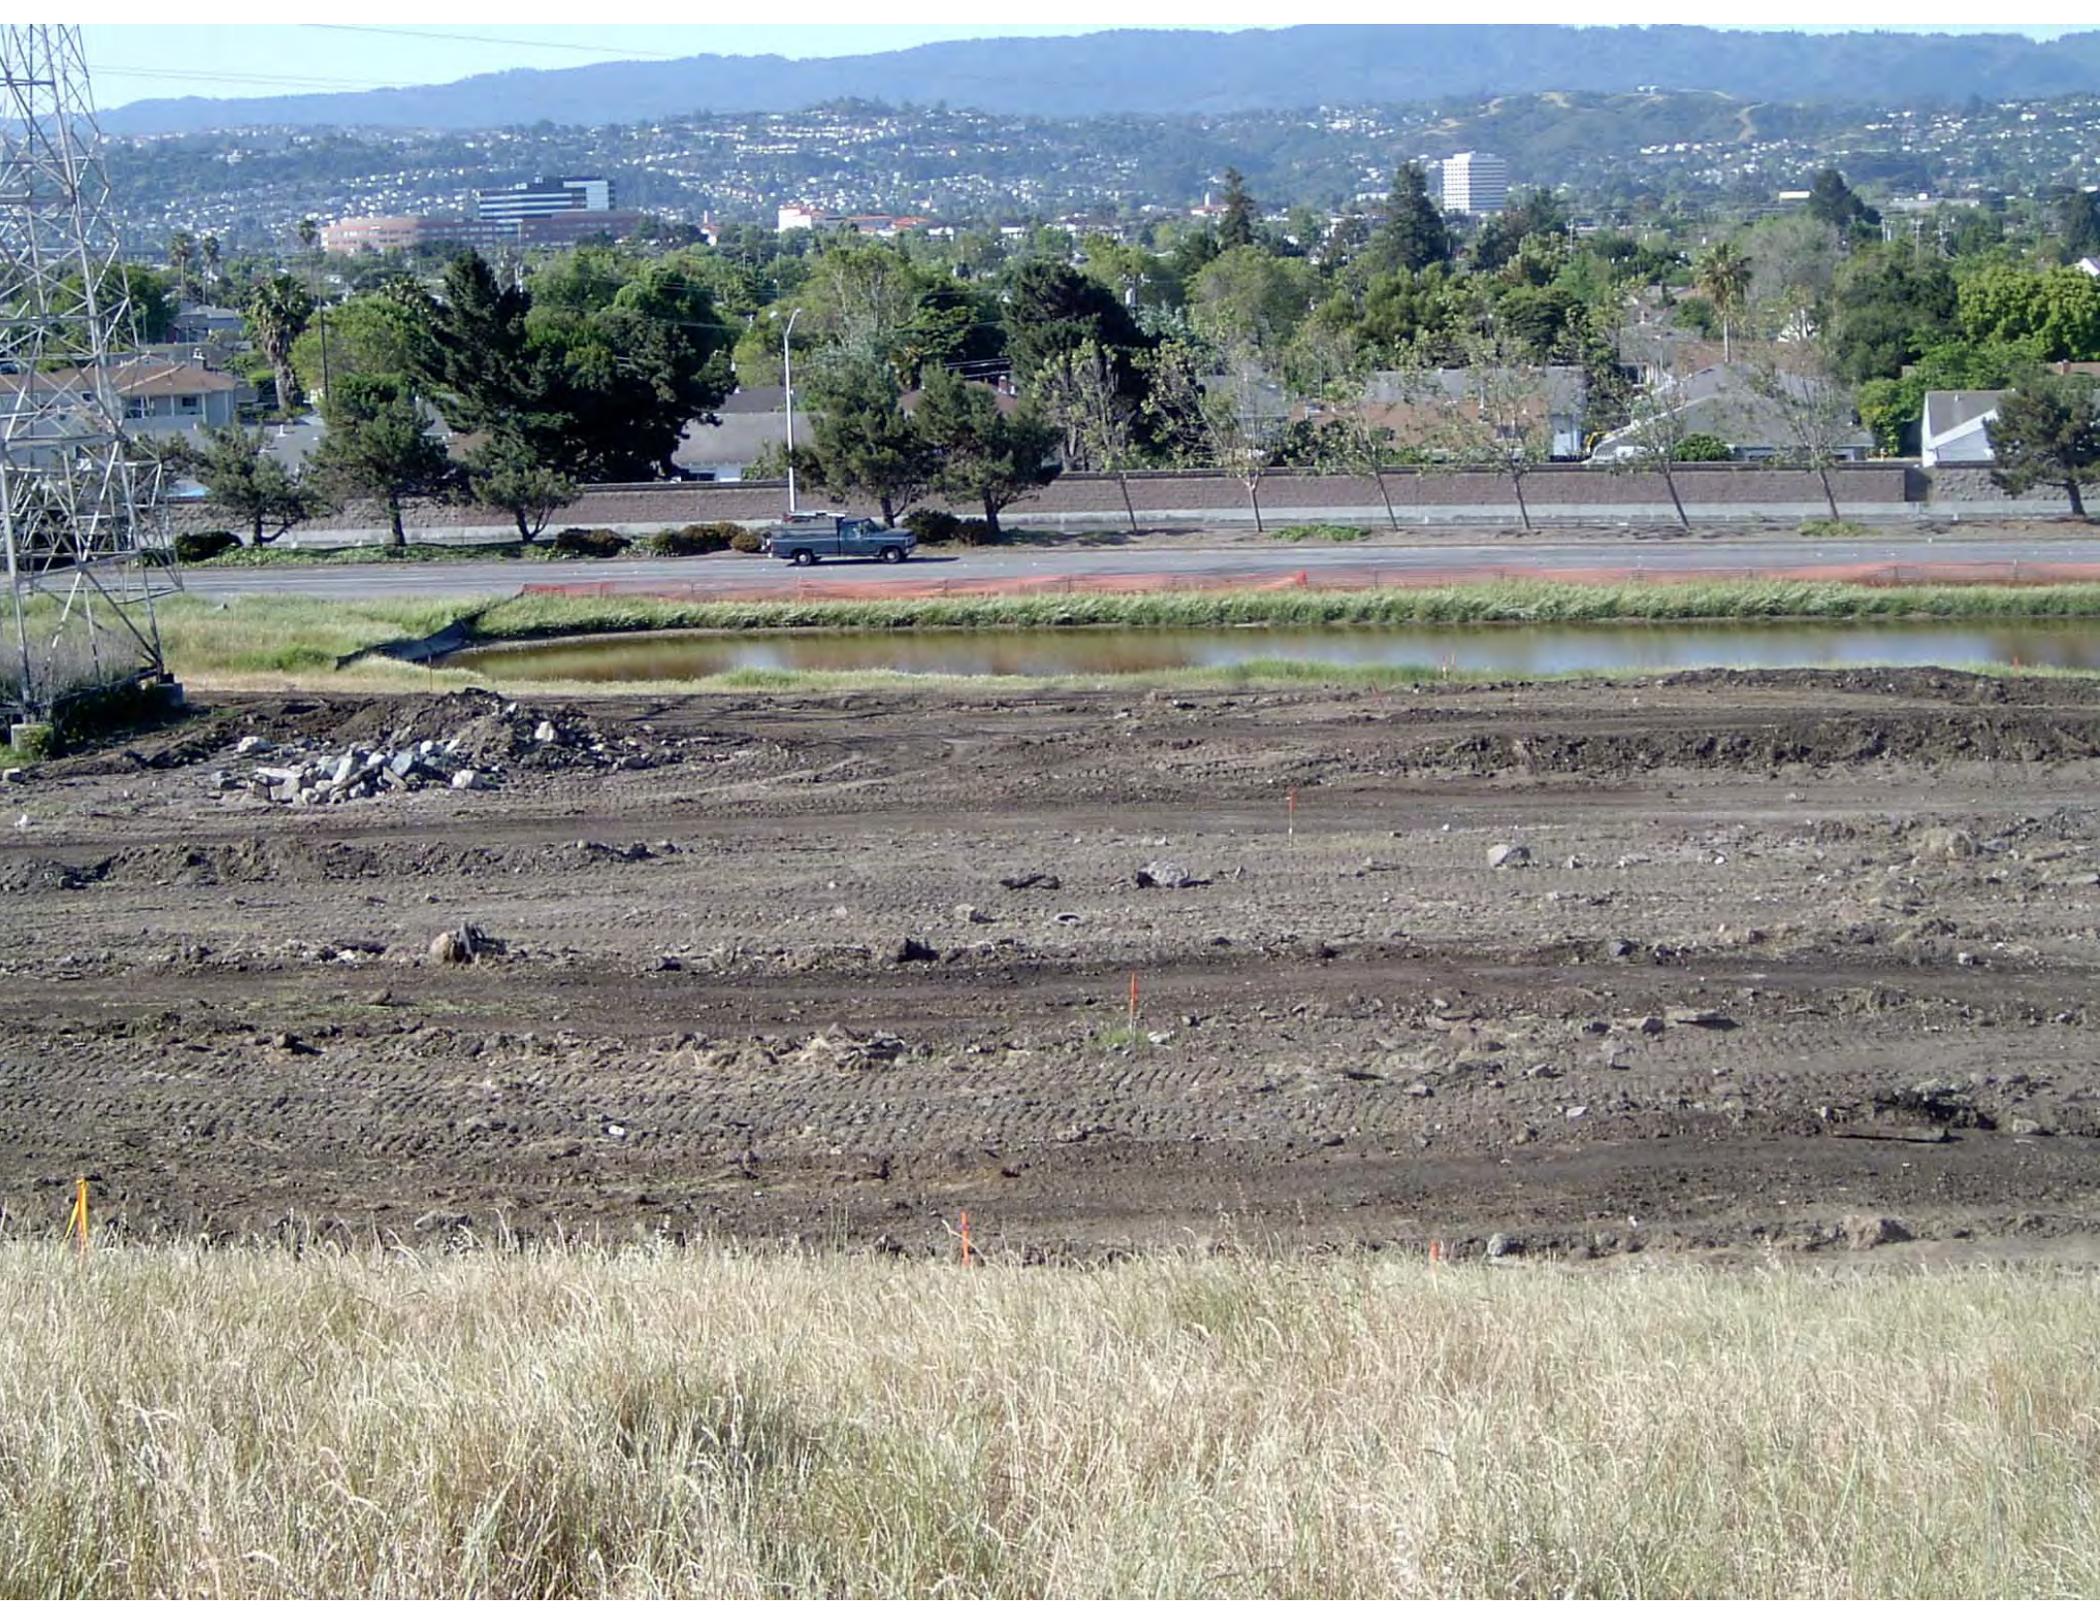
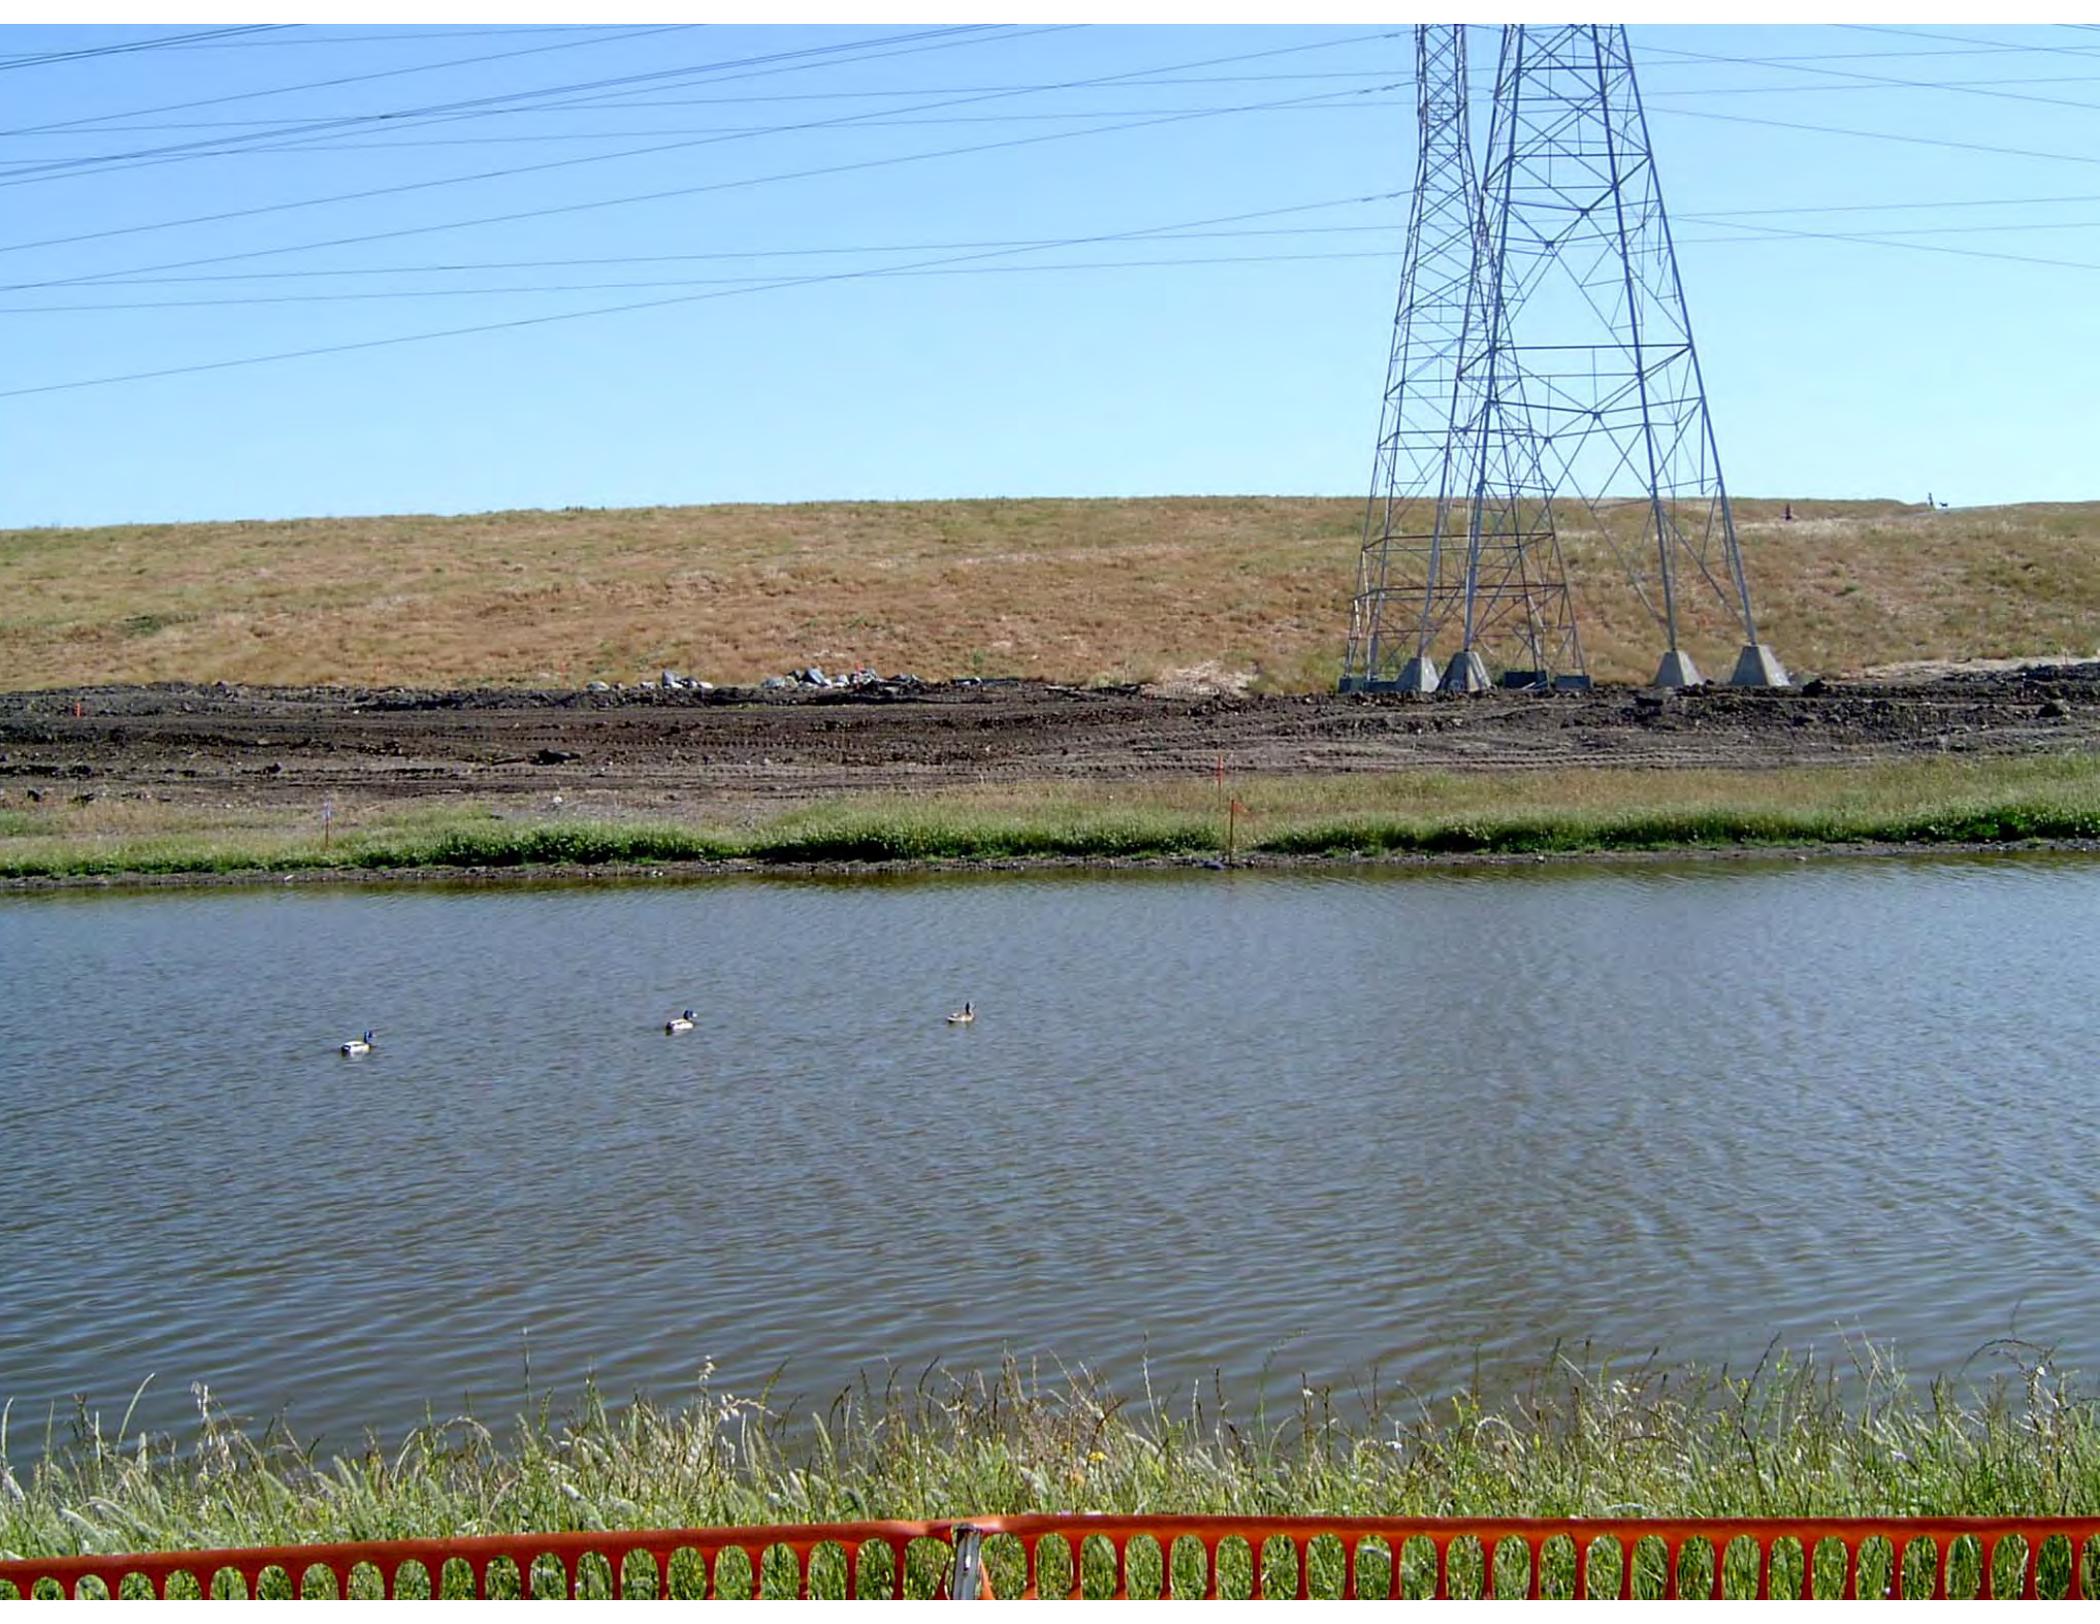
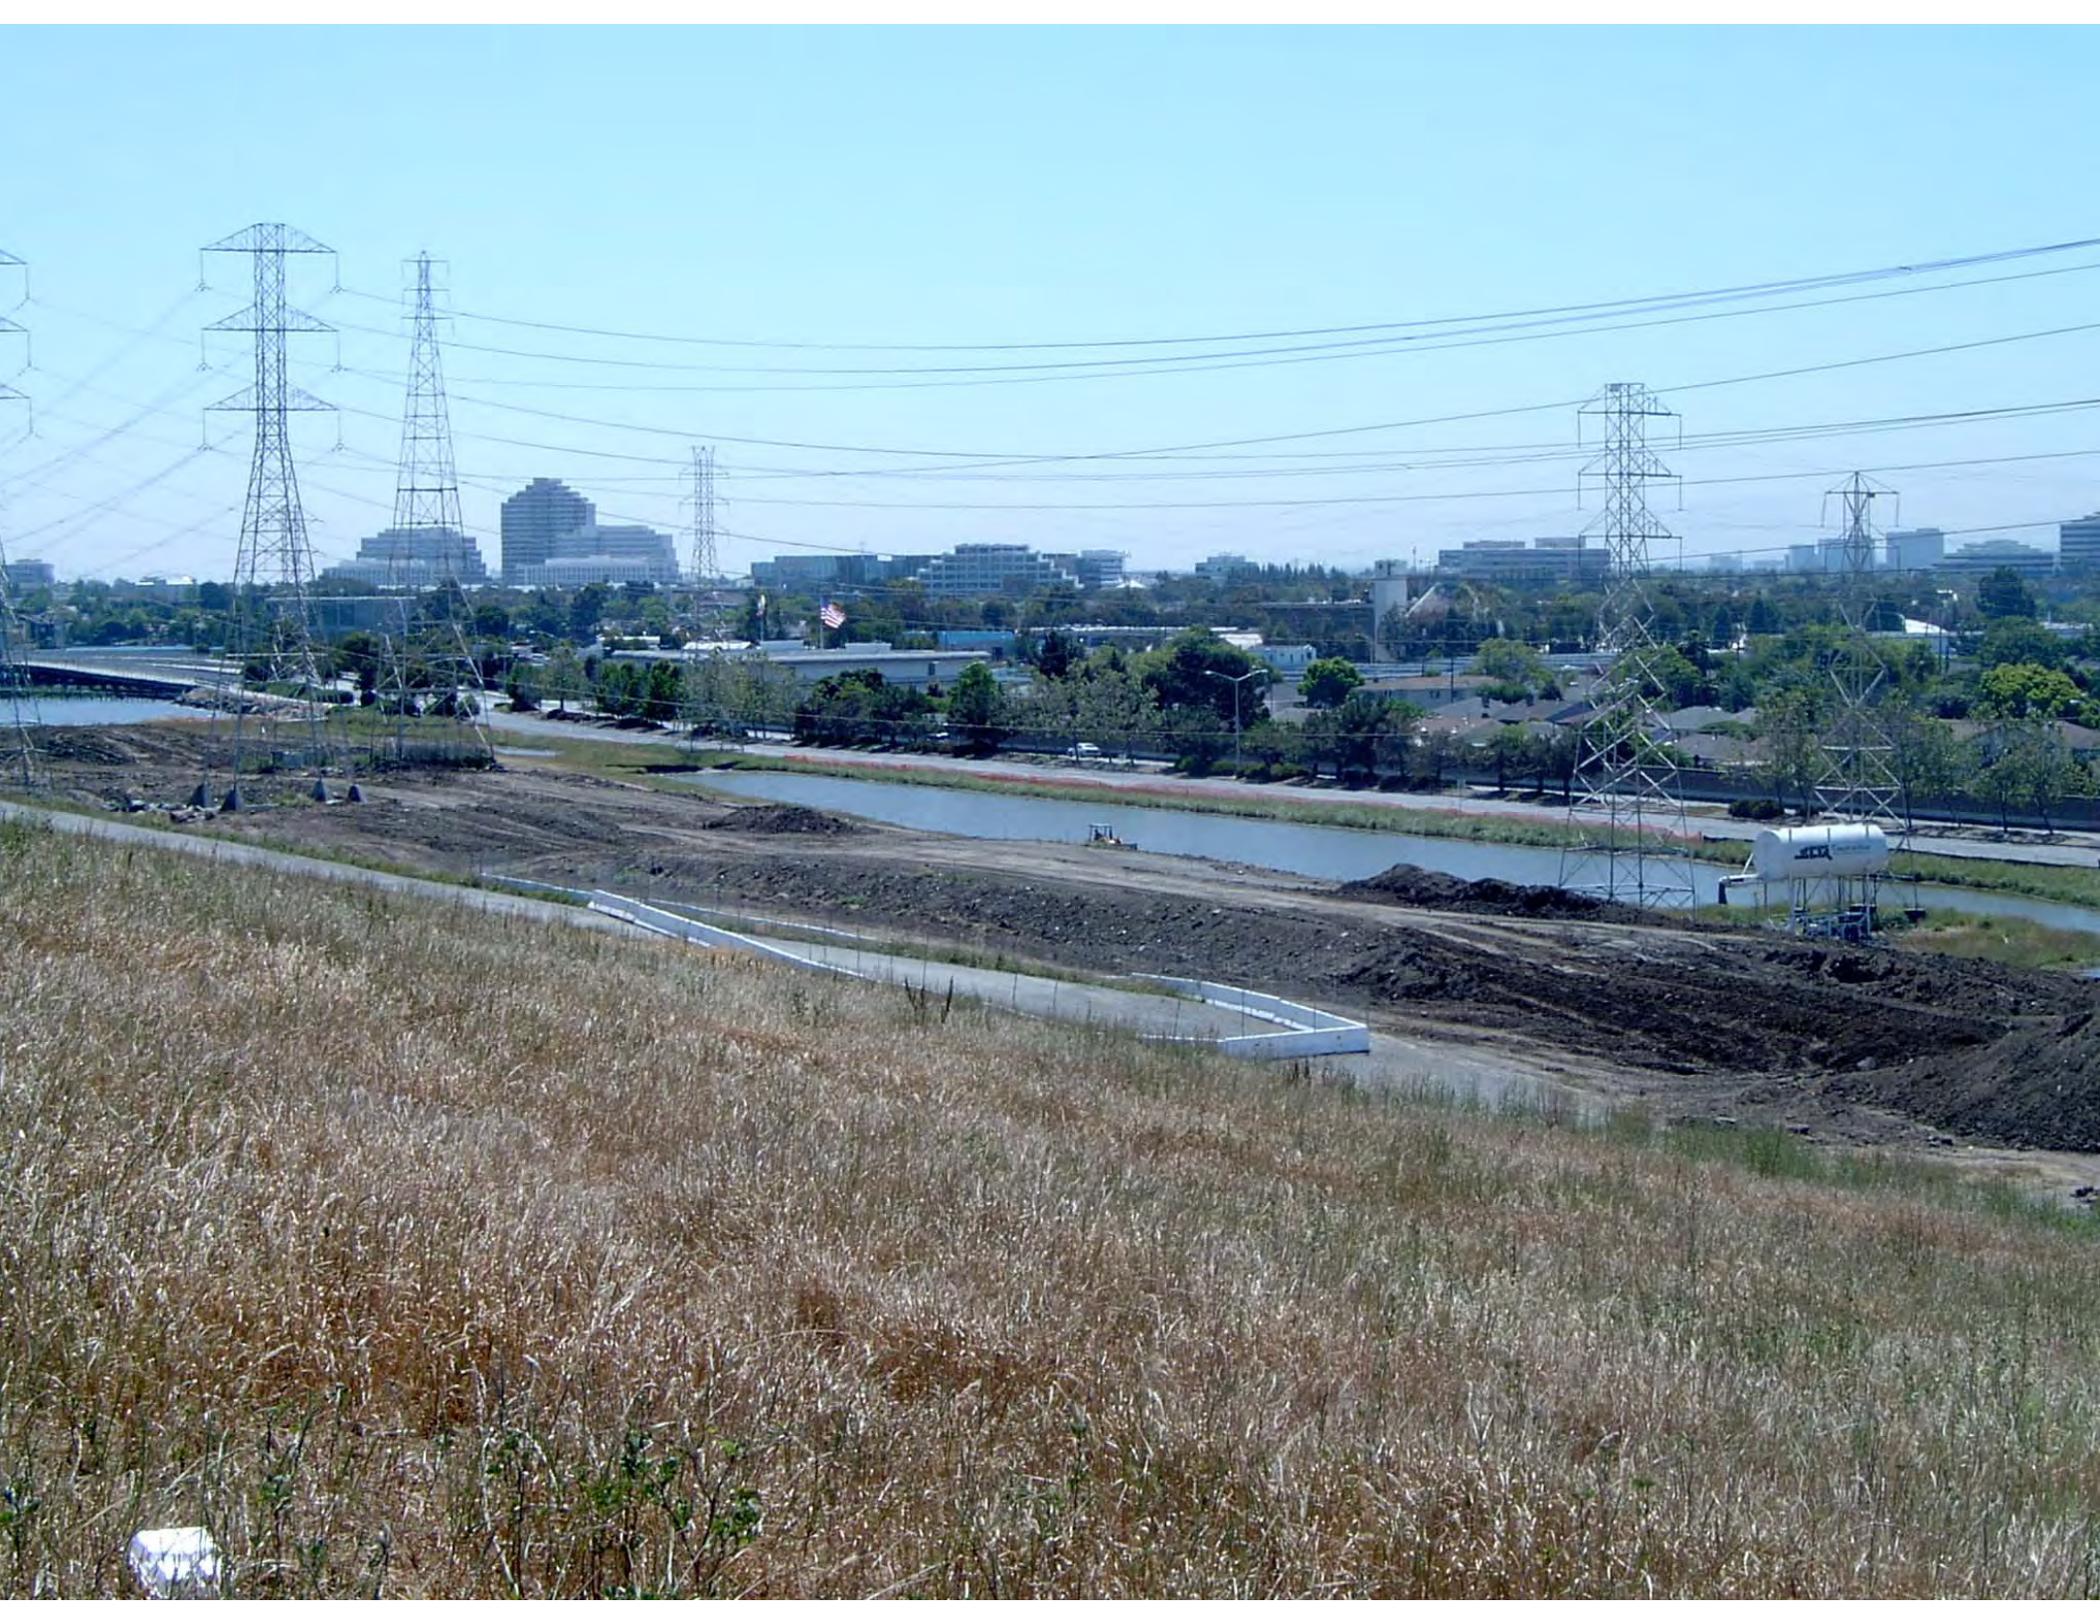
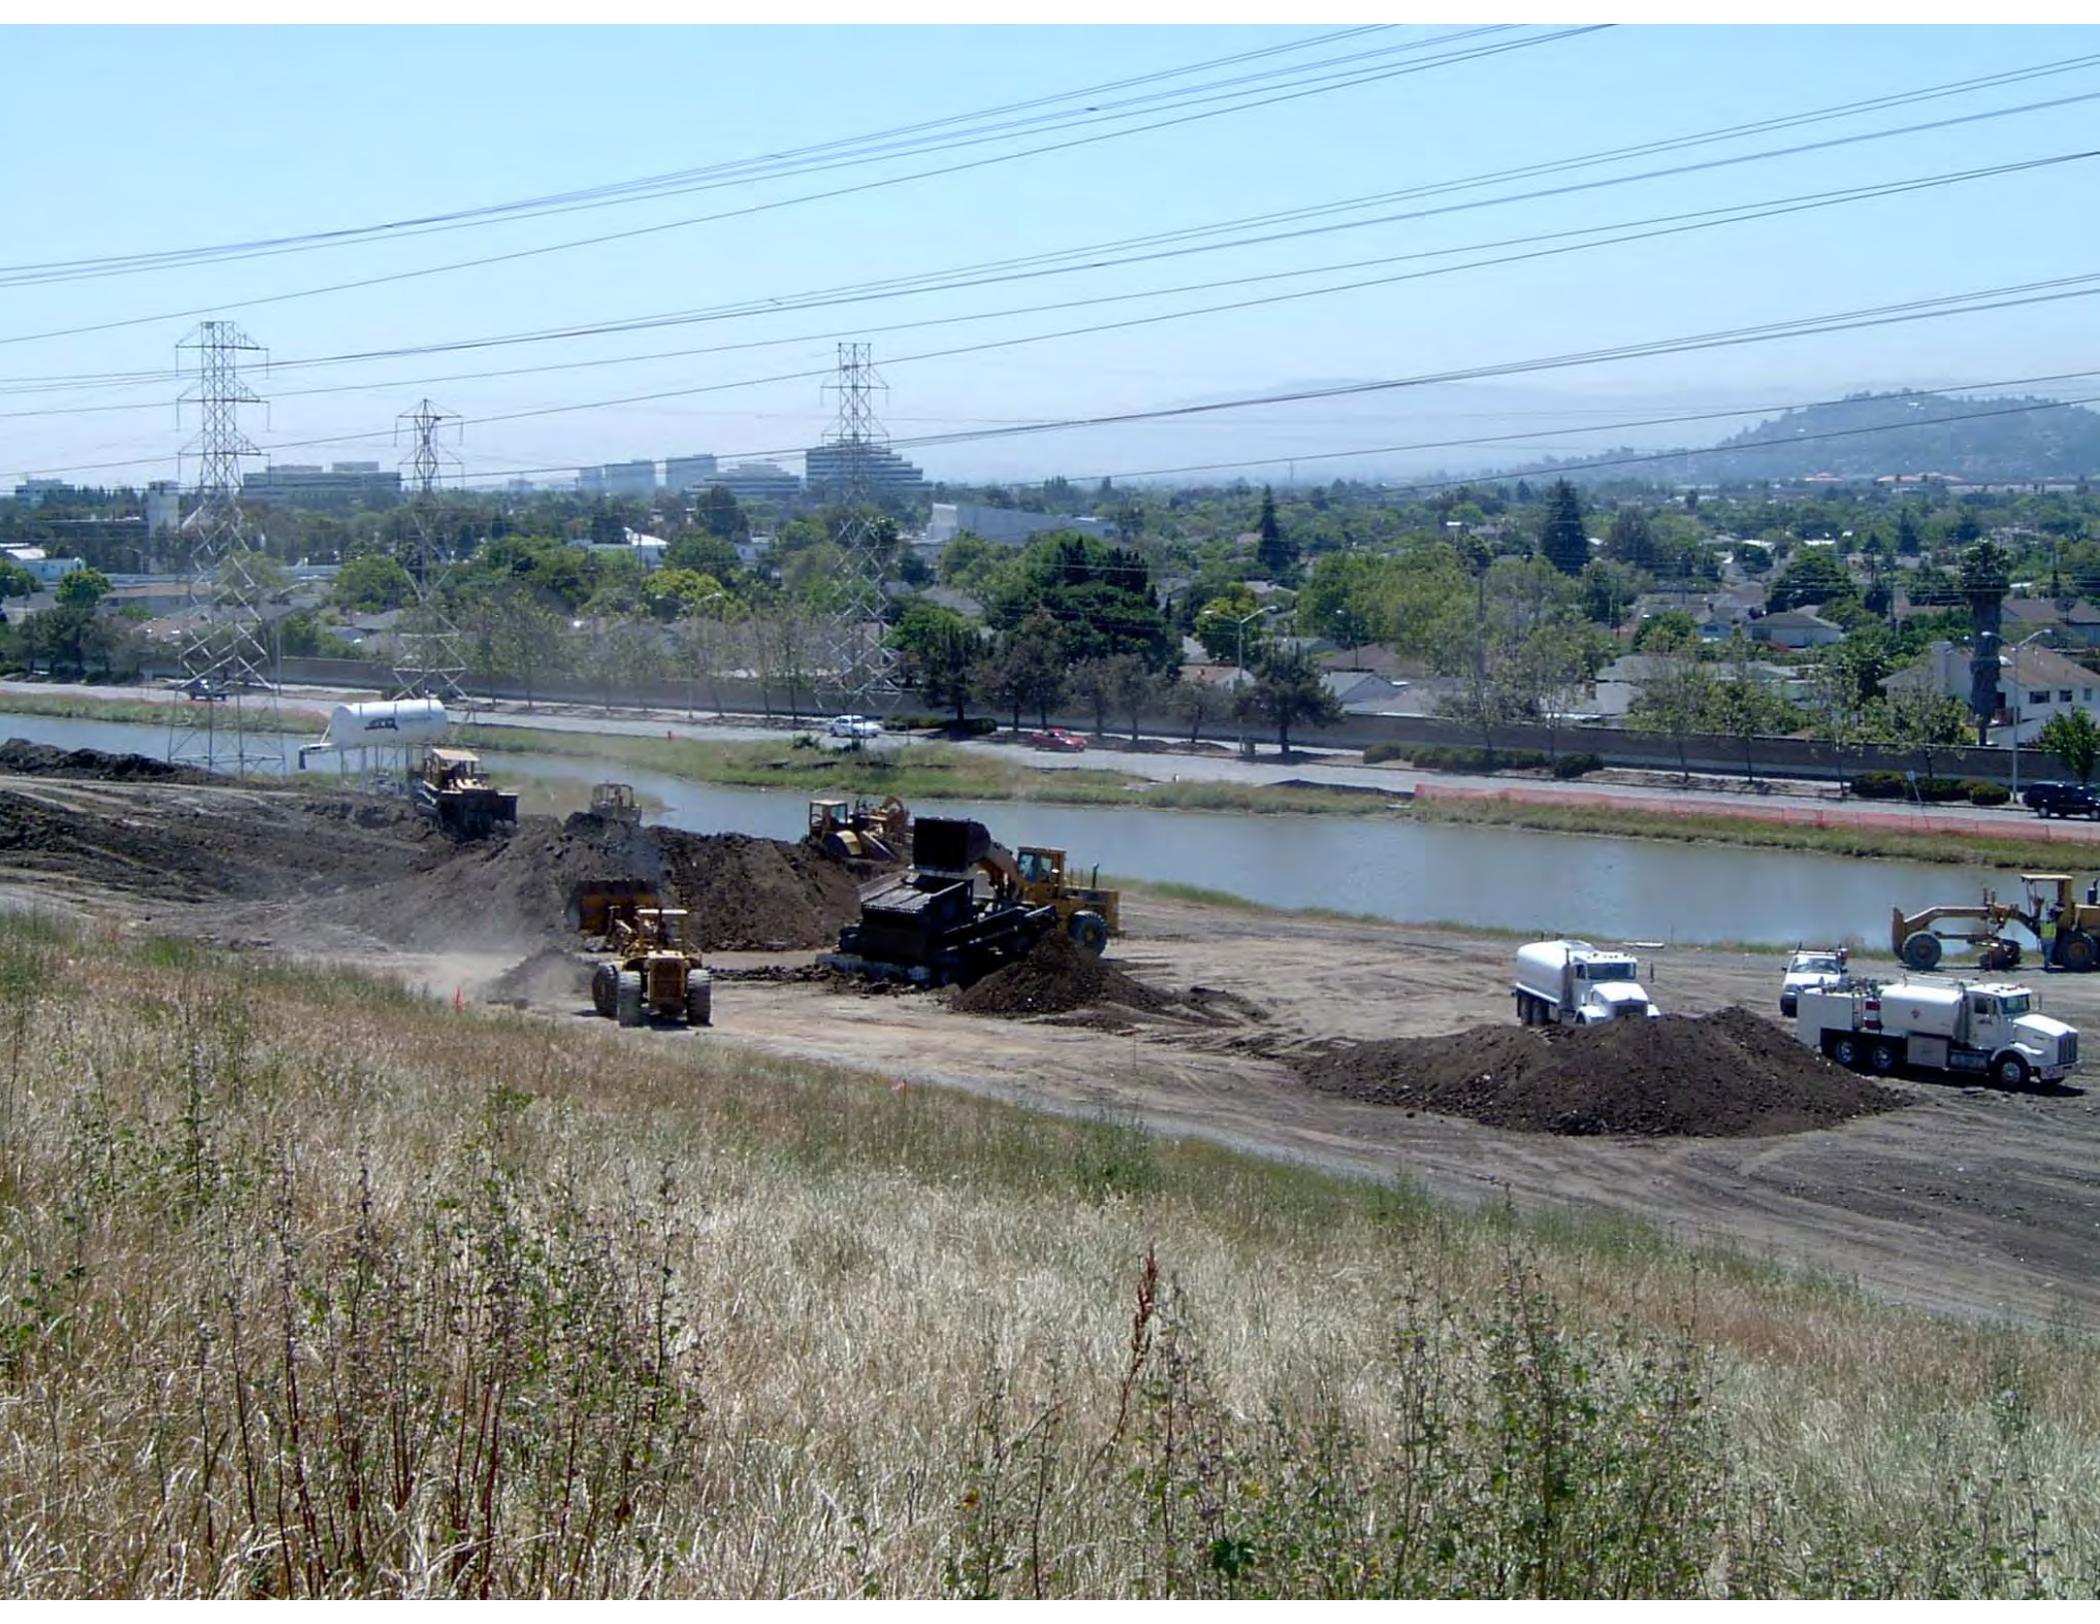
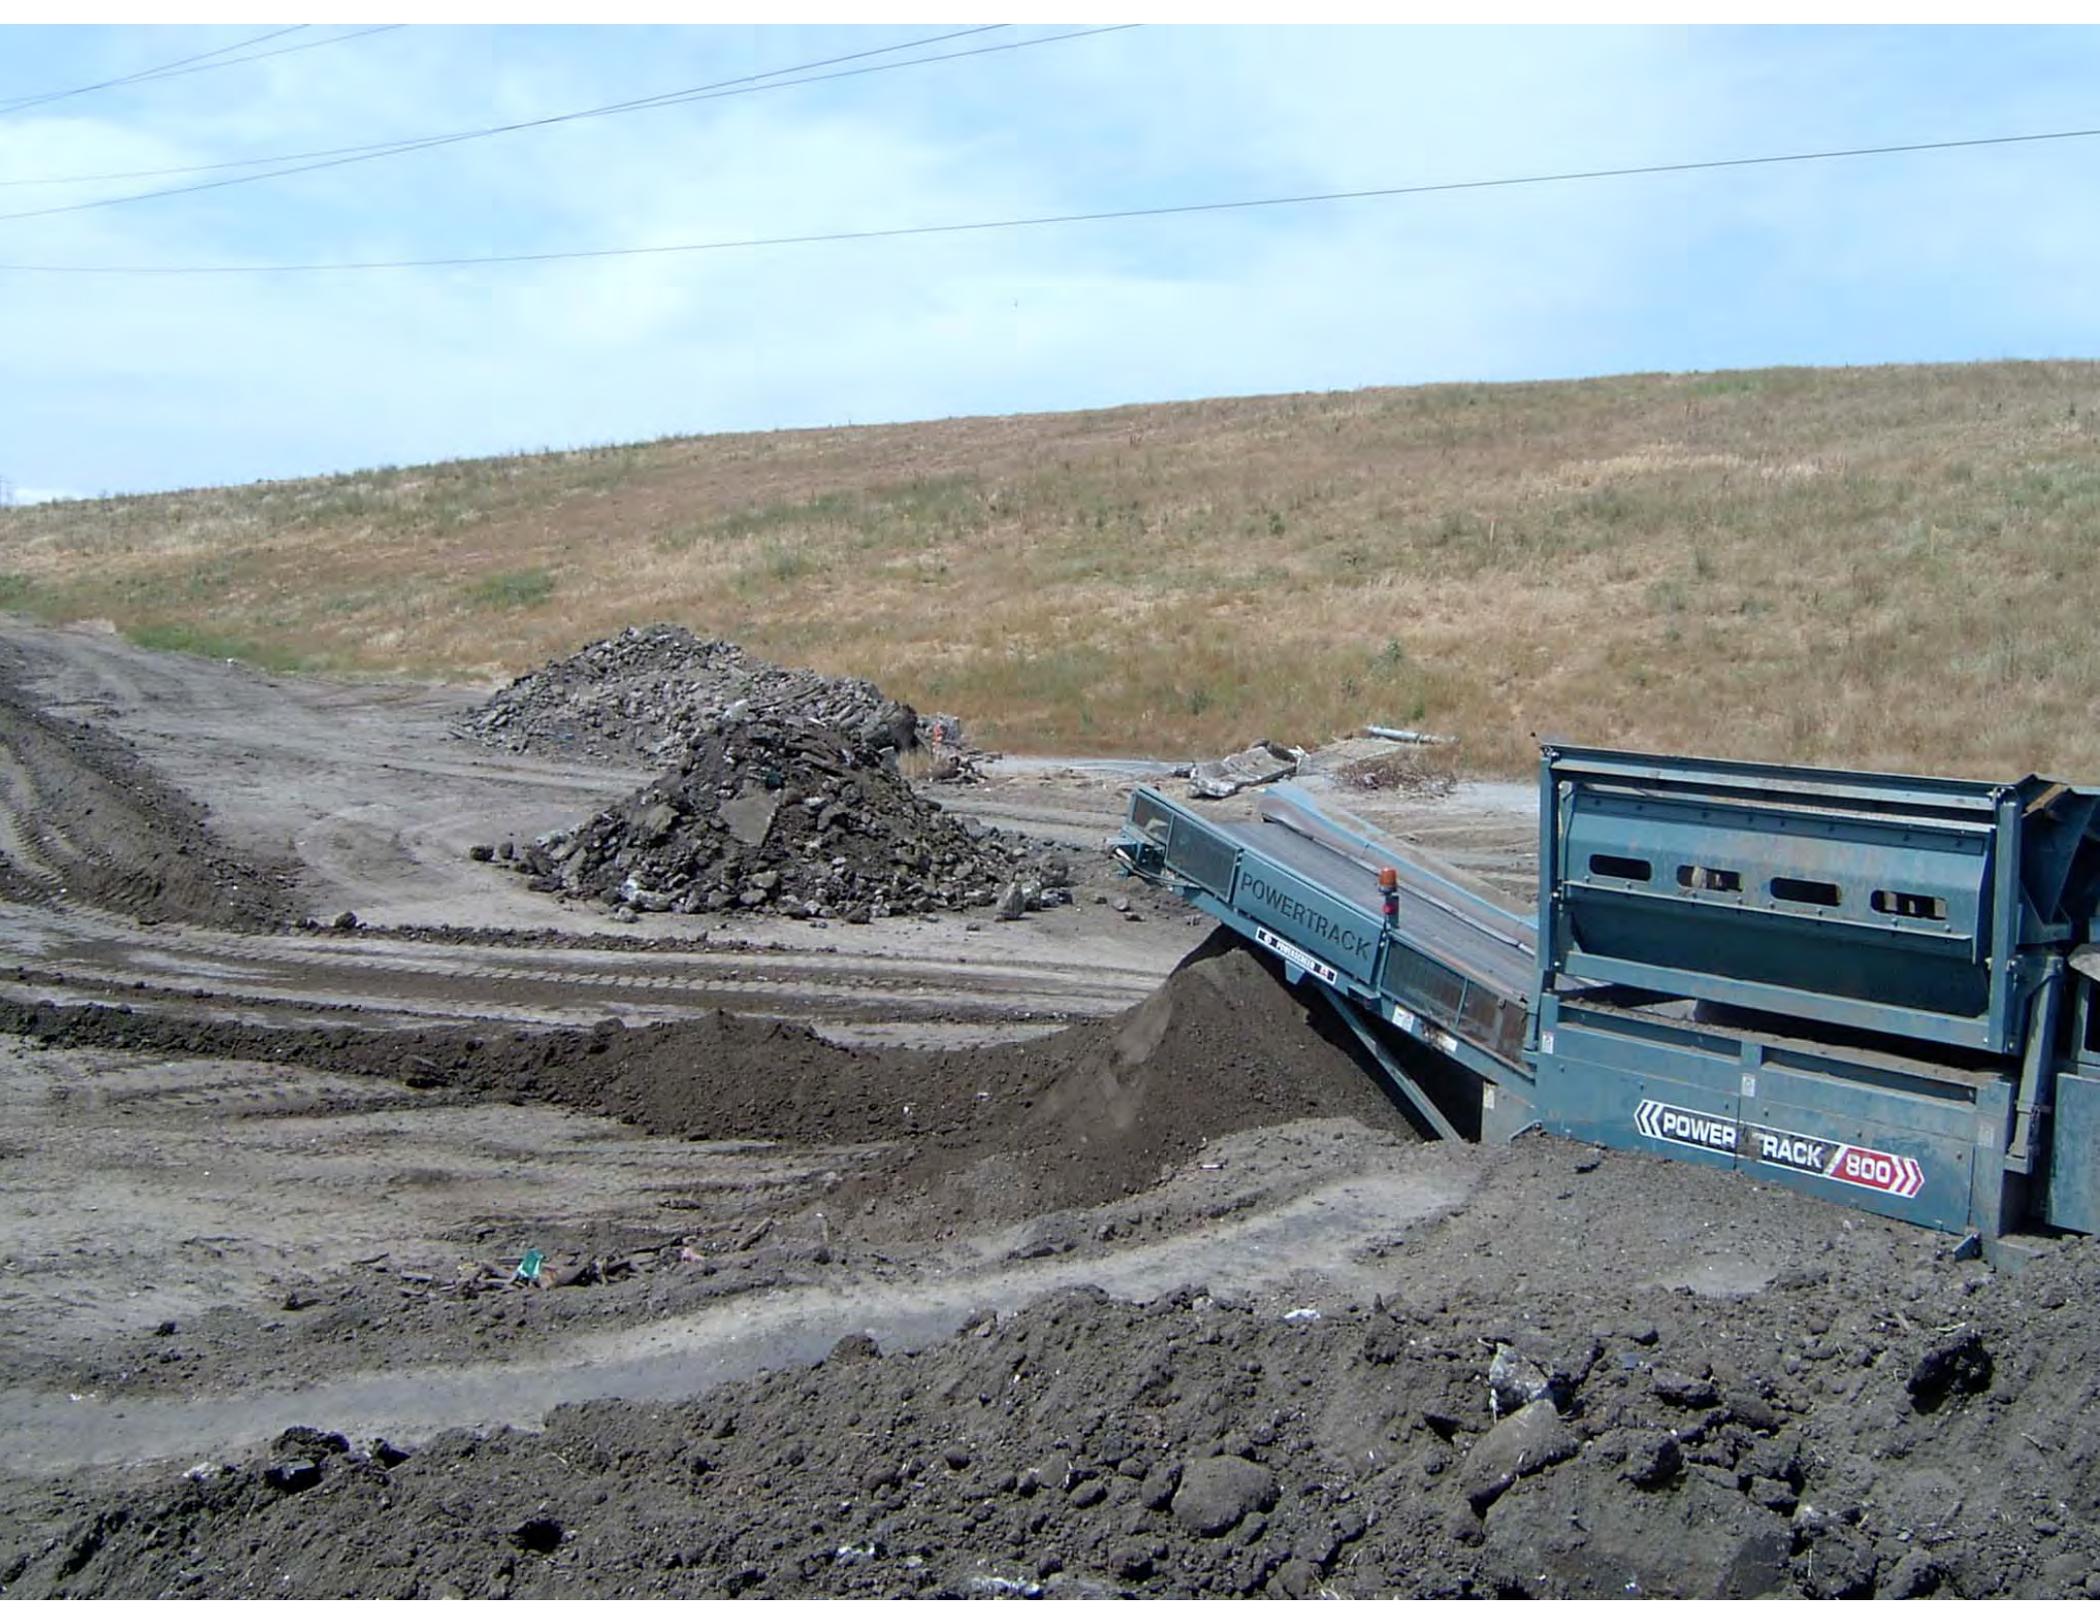
Landfill Cap Concerns

- Foundation and erosion layer thickness
- GCL edge anchorage and overlap
- Integrity of GCL
- Minimize GCL penetrations
- Integrity of GCL penetrations
- Landfill gas migration into buildings
 - LFGM seal (Liquid Boot)
 - Gas capture system
 - Alarm system
- Prepare for and control post-closure development when Park is constructed
